Third Notice of Potential Permit Violations (MVN 2015-02295-WII)
Atchafalaya Basinkeeper and Gulf Restoration Network

Re: Third Notice of Potential Permit Violations, Bayou Bridge Pipeline, LLC (MVN 2015-02295-WII)

Monitoring Report:

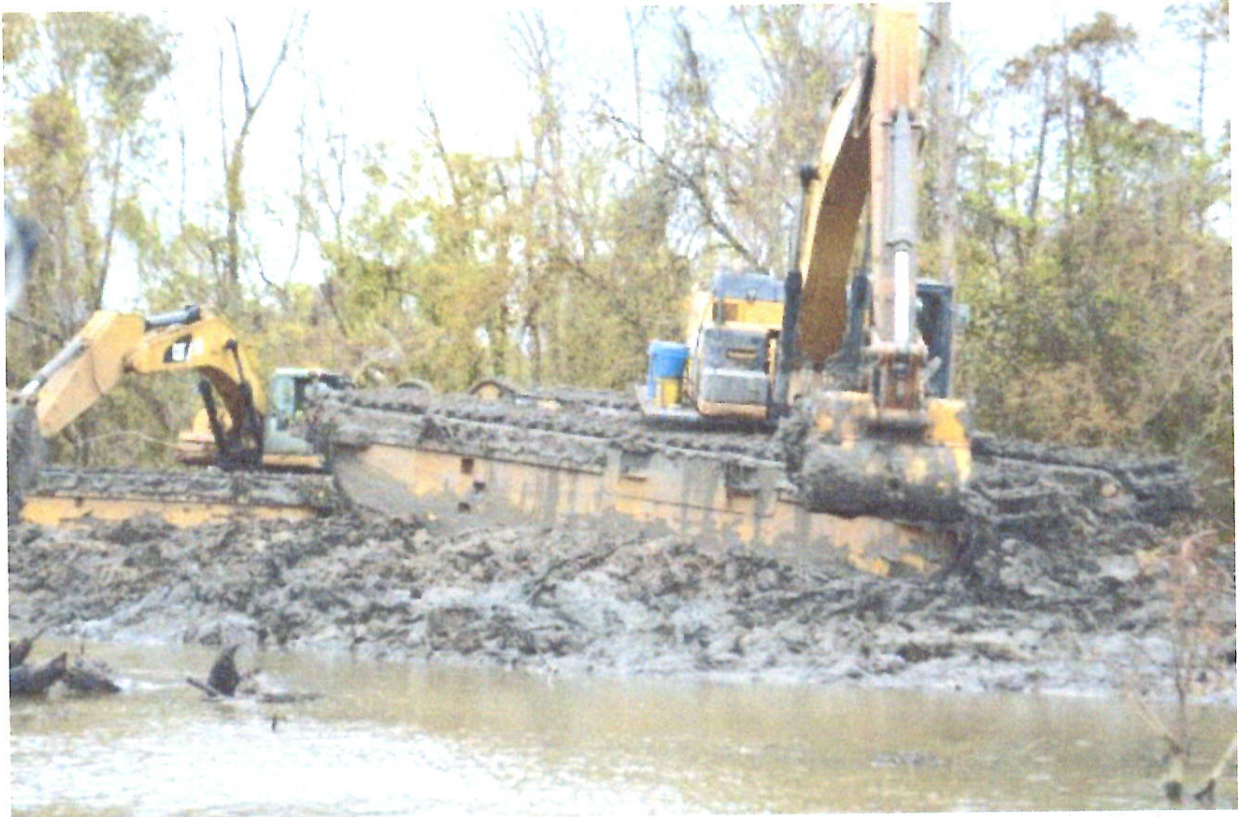
Figure A: This photo was taken by Dean Wilson during the monitoring trip in the Basin on December 7, 2018. This photo was taken approximately 1.5 miles east of Flat Lake Pass. Approximate coordinates 30.08572778, -91.41138889. Figures A-C depict active construction in the area and a lack of erosion or sediment control measures in place.

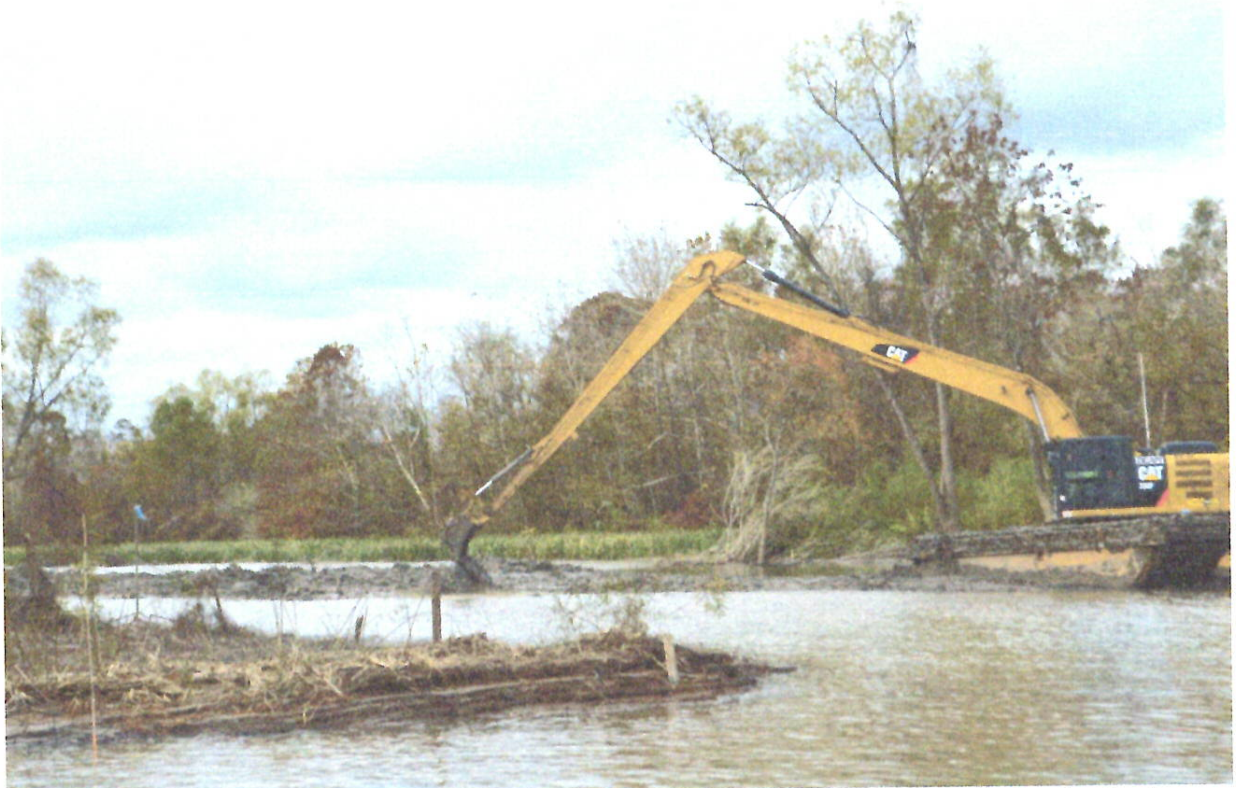
Figure B: This photo was taken by Dean Wilson during the monitoring trip in the Basin on December 7, 2018. This photo was taken in the same location as Figure A. This photo depicts active construction in the area and again, a lack of erosion or sediment control measures in place.

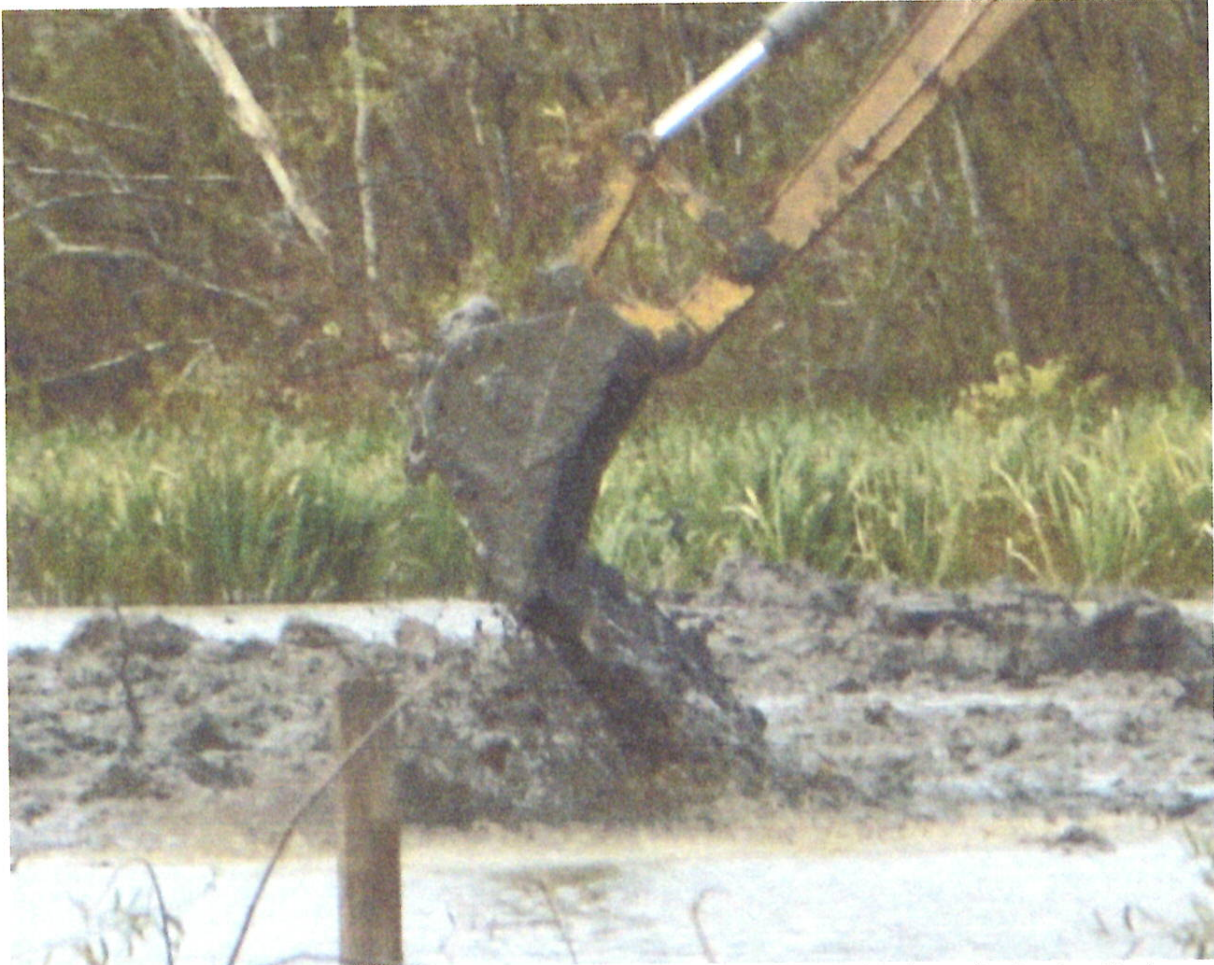
Figure C: This photo was taken by Dean Wilson during the monitoring trip in the Basin on December 7, 2018. This photo was taken in the same location as Figures A and B above. This photo more clearly depicts the discharge of mud from construction.

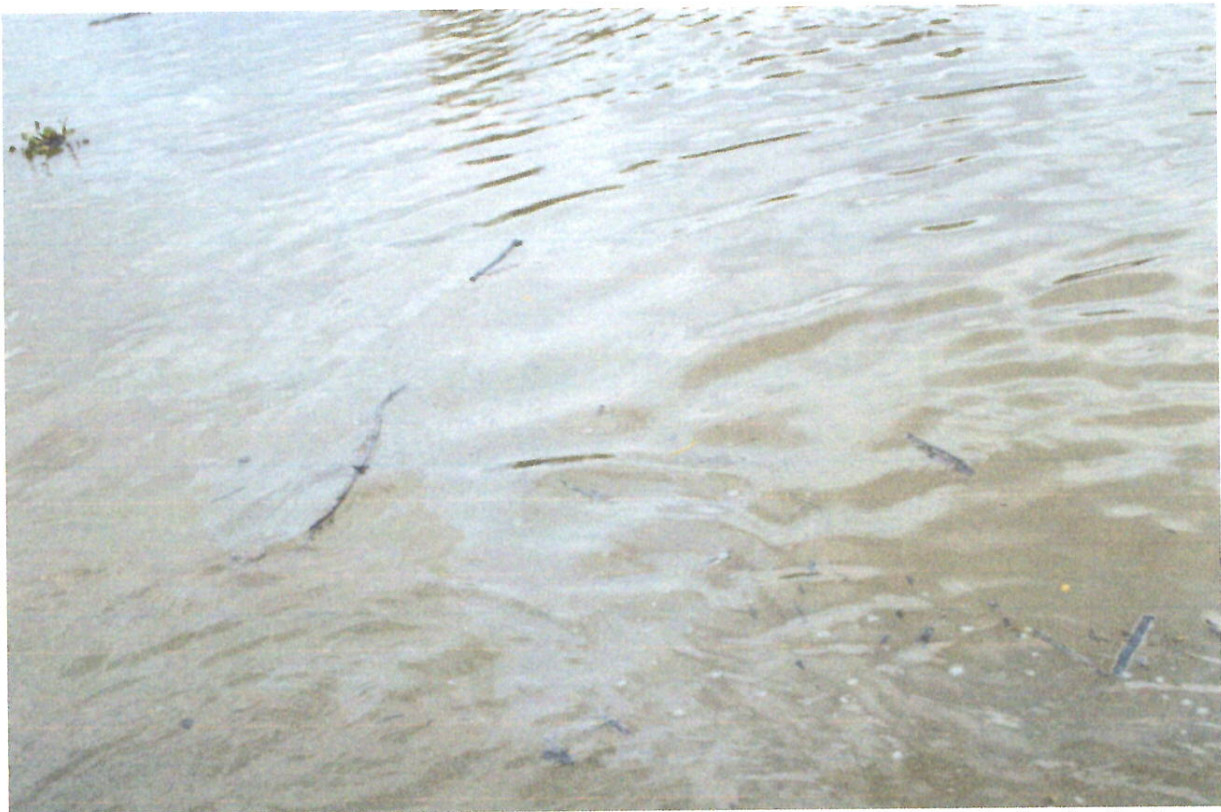
Figure D: This photo was taken by Dean Wilson during the monitoring trip in the Basin on December 7, 2018. This photo was taken approximately 0.8 of a mile west of Cross Bayou. Approximate coordinates: 30.08656111, -91.39194444. This photo depicts diesel sheen on the water.

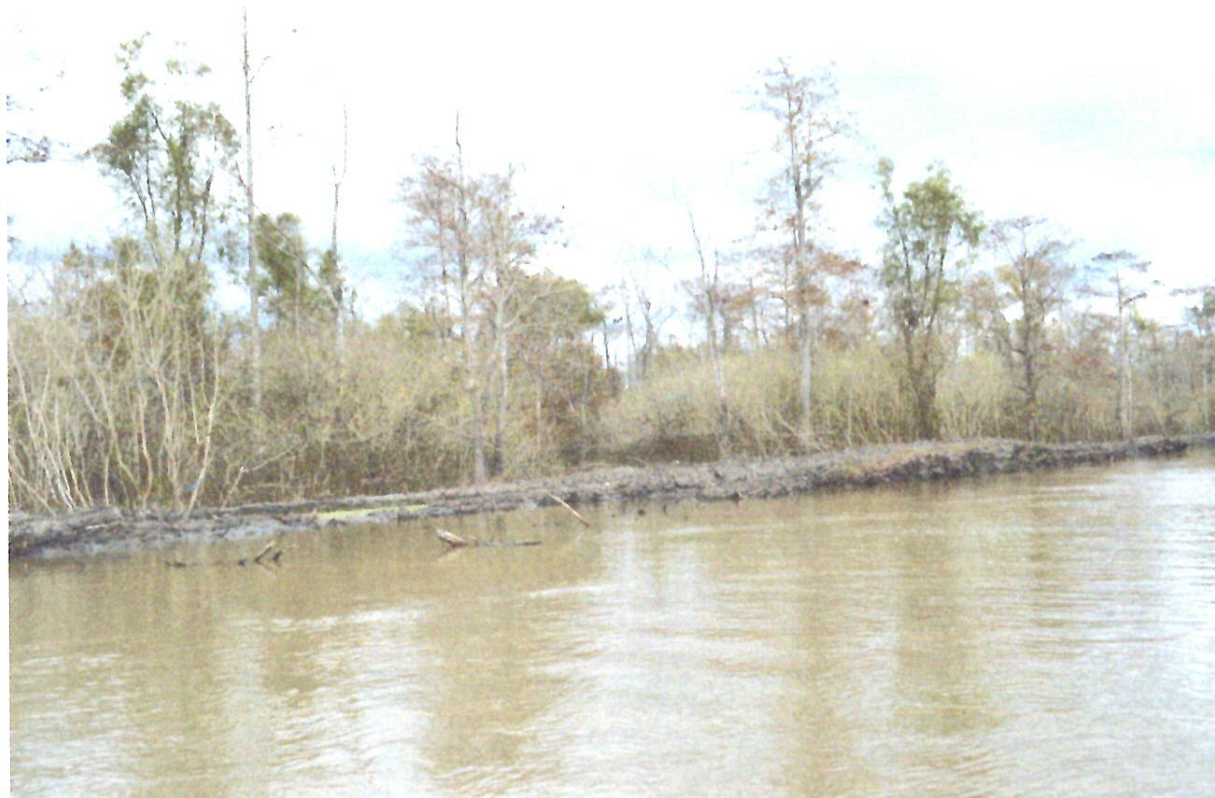
Additionally, during the monitoring trip on December 7, 2018, Basinkeeper identified a blocked/dammed waterway on the east side of the Basin approximately 1.3 miles west of Cross Bayou. Figure E below depicts the blocked waterway.

Figure E: This photo was taken by Dean Wilson during the monitoring trip in the Basin on December 7, 2018. This photo was taken at the following approximate coordinates: 30.08608056, -91.39916667. This photo depicts a waterway dammed by pipeline construction in this area.

The Corps' Permit prohibits the activity from interference with the public's right of free navigation of *all* navigable waters of the United States. *See* U.S. Army Corps of Engineers Permit # MVN-2015-02295-WII to Bayou Bridge Pipeline, LLC, at 4, (Dec. 14, 2017) (hereinafter, "BBP § 404 Permit") (emphasis added). The addition of sediment into navigable waters, elevating the water bottom, and the blockages of waterways from construction activities and debris impedes navigation.

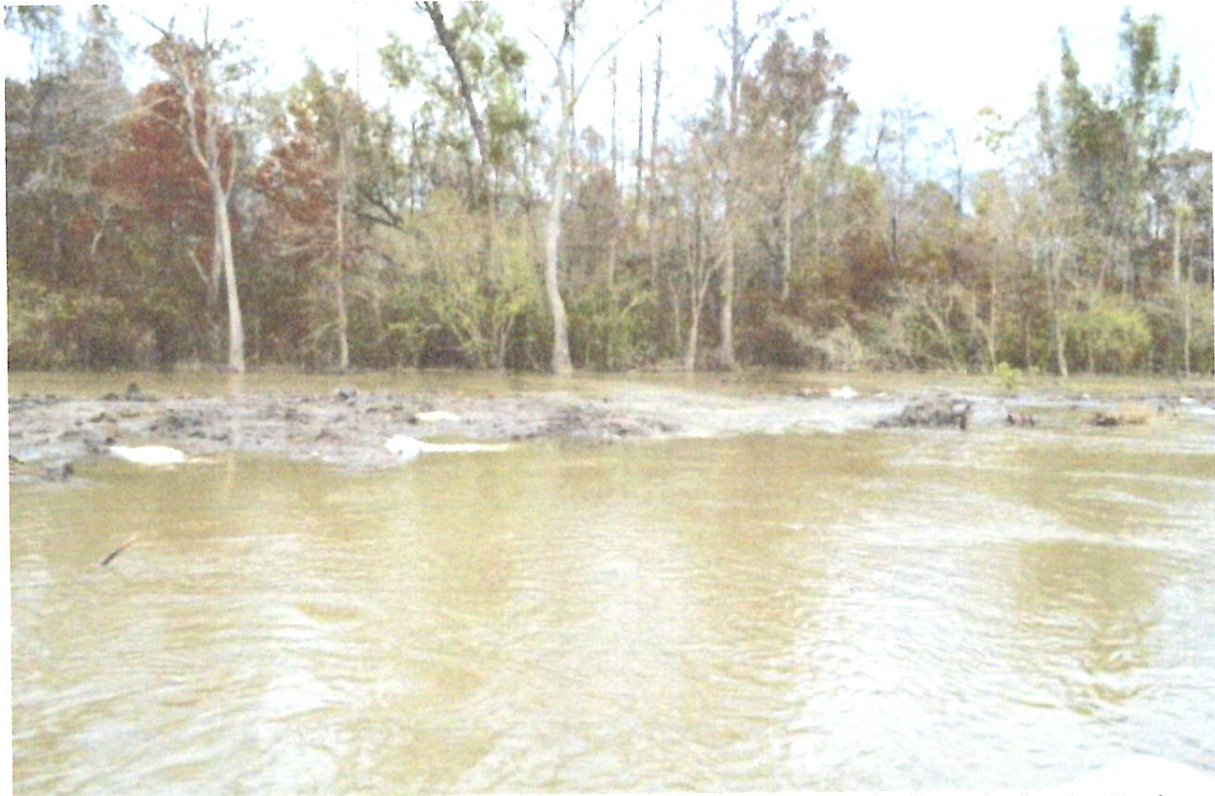
Figure F: This photo was taken by Dean Wilson during the monitoring trip in the Basin on December 7, 2018. This photo was taken at the following approximate coordinates: 30.08576944, -91.41333333. This photo depicts trash and debris in the construction right-of-way being carried by the current into the wetlands. The presence of trash presumably left behind from construction can be found in various places along the right-of-way.

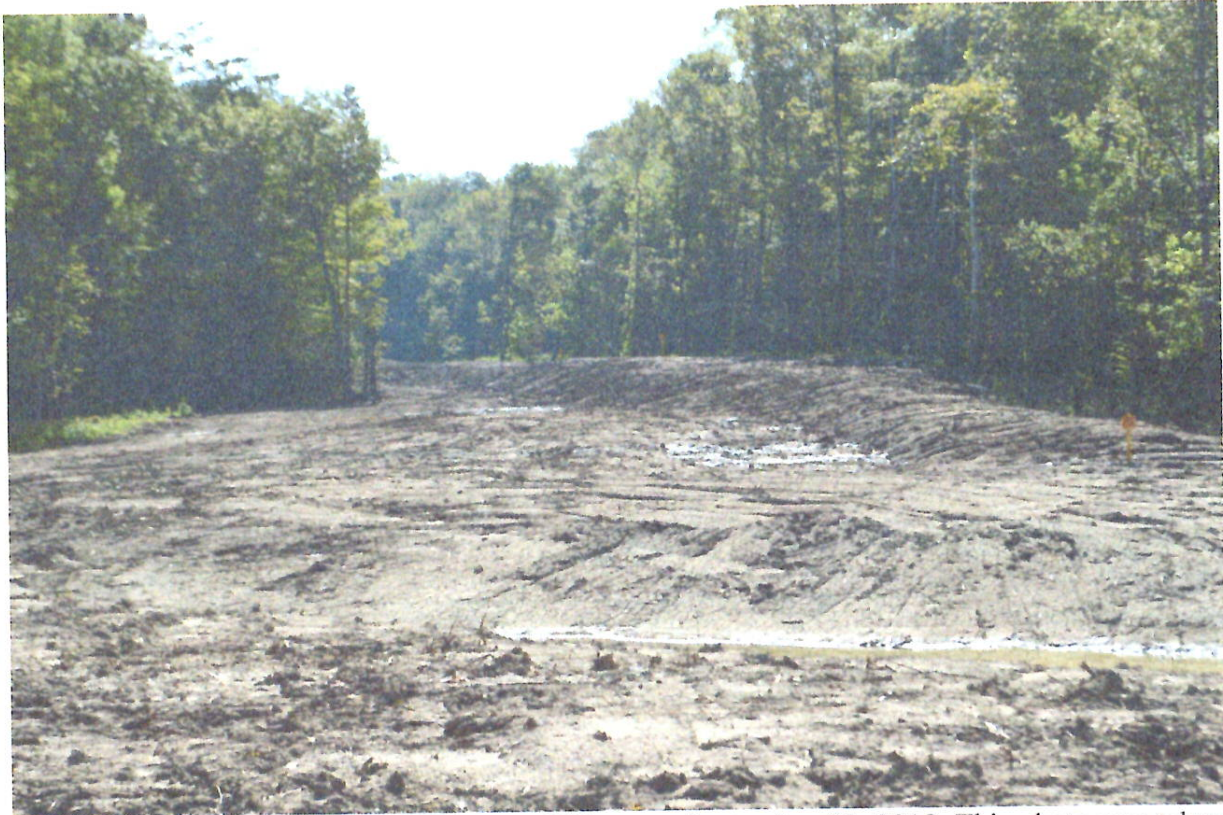
Figure G: This Photo was taken by Dean Wilson on September 20, 2018. This photo was taken facing southeast along the pipeline right-of-way at approximately 30.11311944, -91.54972222. This photo depicts an existing spoil pile on the south side of the pipeline right-of-way, and pipeline markers on top of the spoil pile.

However, despite such assurances from BBP that it will not install the pipeline within any existing spoil bank, we have observed pipeline markers on existing spoil (see Figure G *infra*) in areas particularly on the west side of the Atchafalaya Basin. In light of the many concerns raised during the permit comment period with respect to spoil piles and the depth of pipeline construction, it is important that the Corps investigate whether these assurances that the Corps relied on in making its determination of no significant impact and issuing the permit have in fact been followed.²

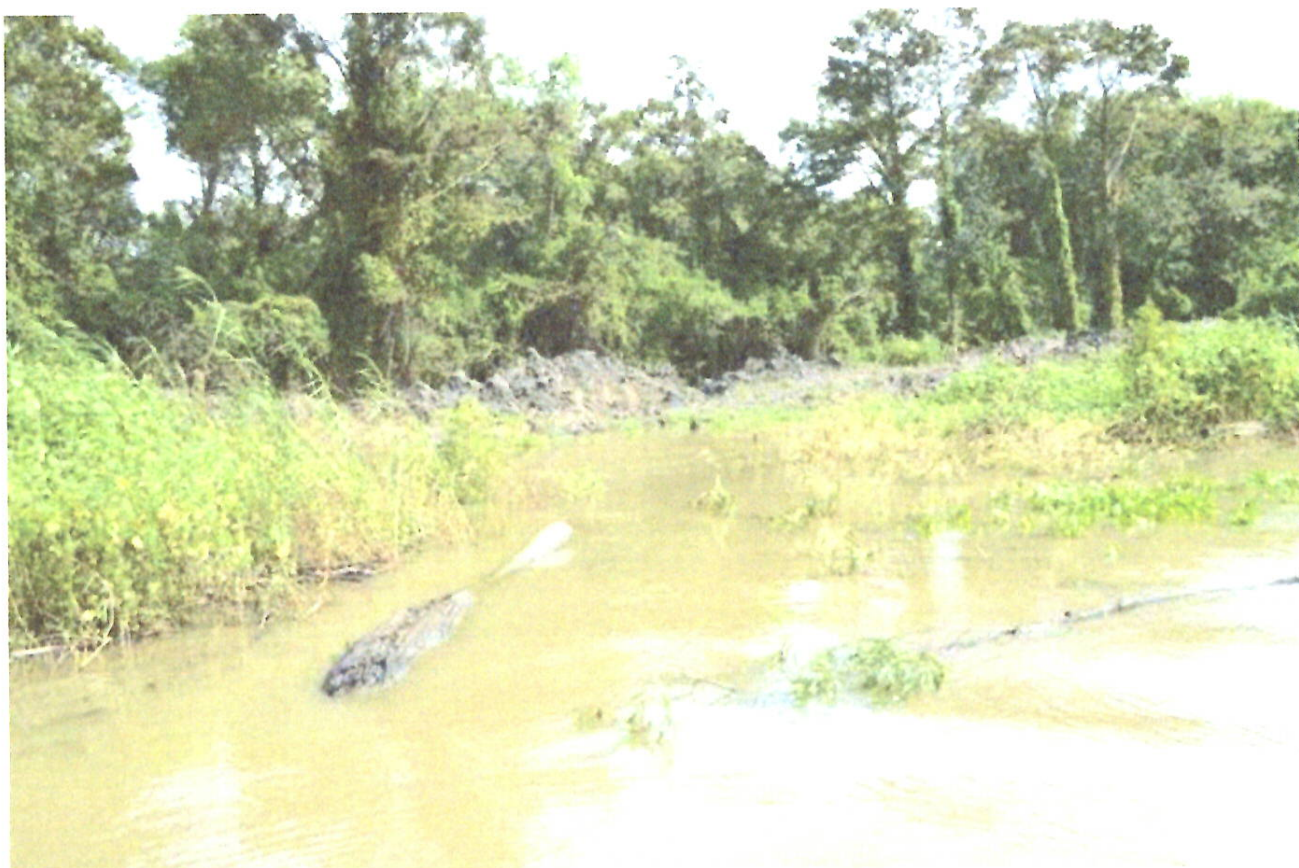
The name on the excavators is DEAN. In places the company was digging in water, with rivers of mud cascading from the bucket and floating all over the place. The damage to the wetlands by digging during high water is hard to describe and impossible to quantify. Some Gaps were kept but many of them were 10 to 20 feet and very far apart (special condition No. 20 to the permit requires 50 foot gaps for every 500 feet of temporary side cast material). Many waterways and small bayous were dammed including Bayou Set, which has become impassible.

Picture of Bayou Set dam

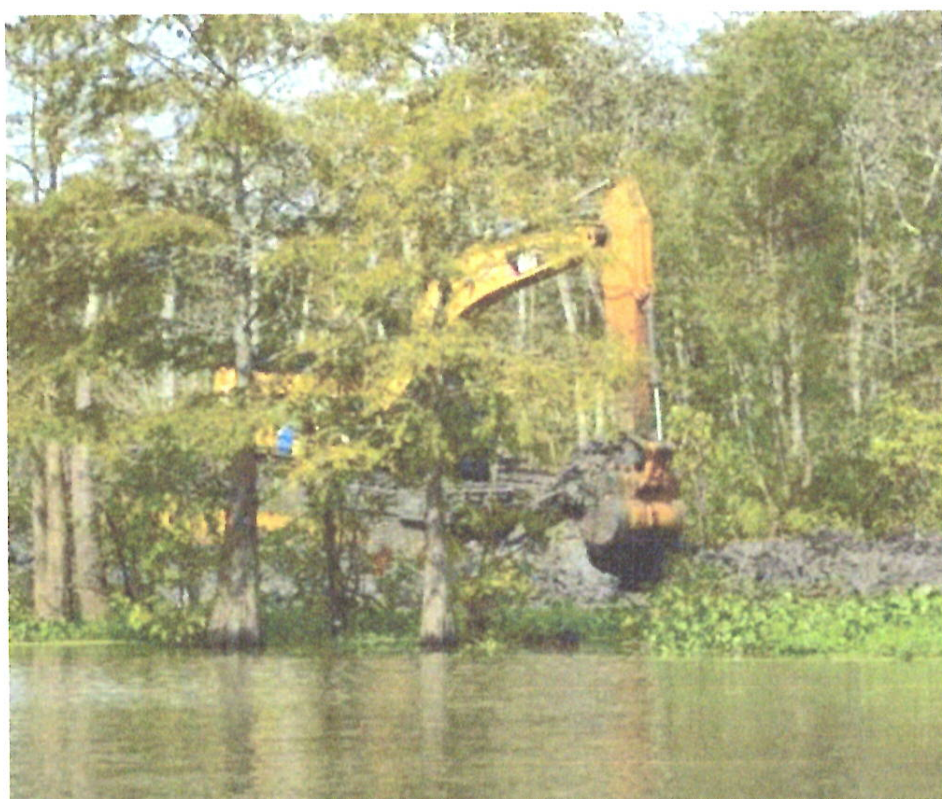
Excavator digging

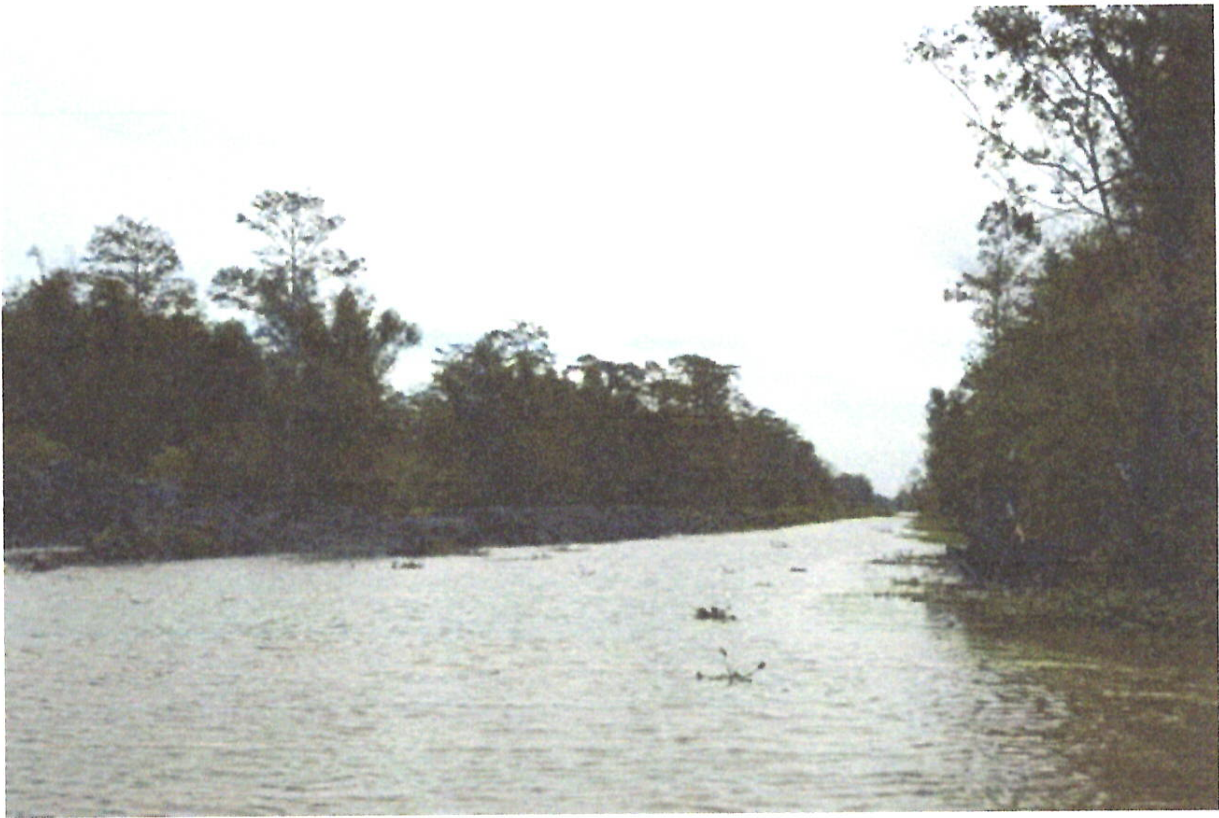
Spoil bank, no gaps

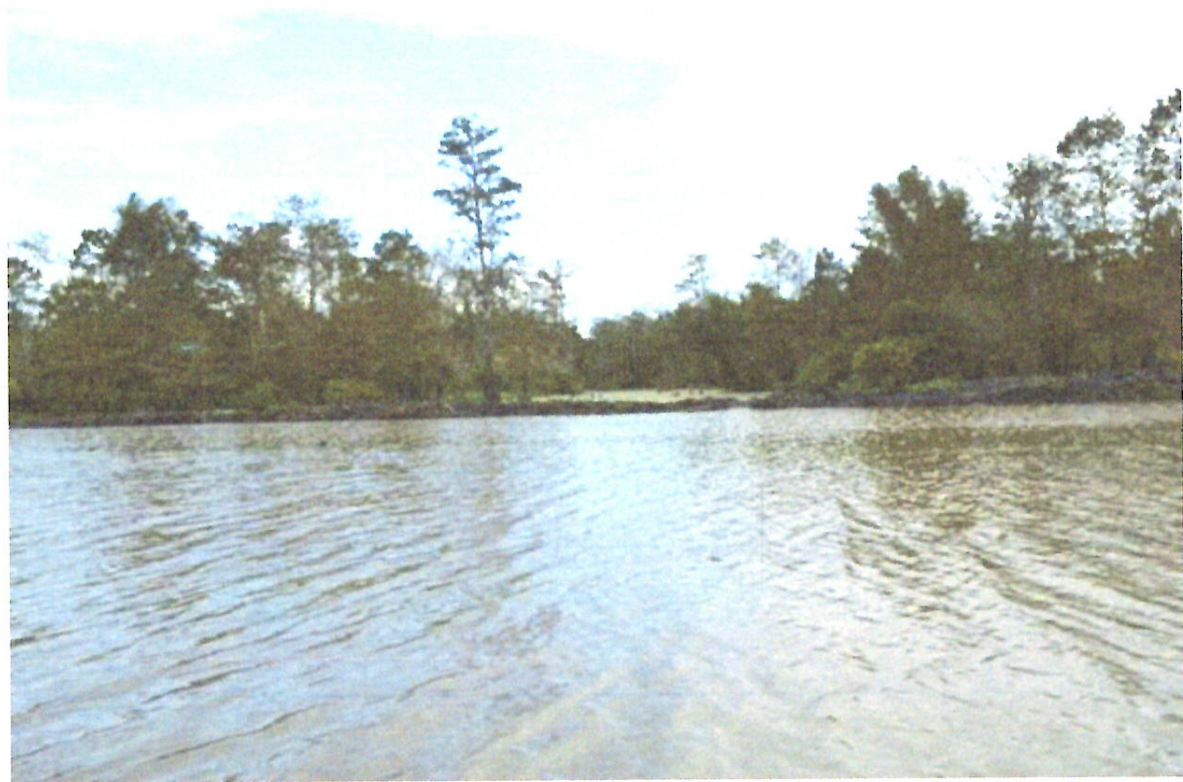
Another small unnamed bayou was dammed 12,000 yards west of Cross Bayou.

Unnamed bayou dam

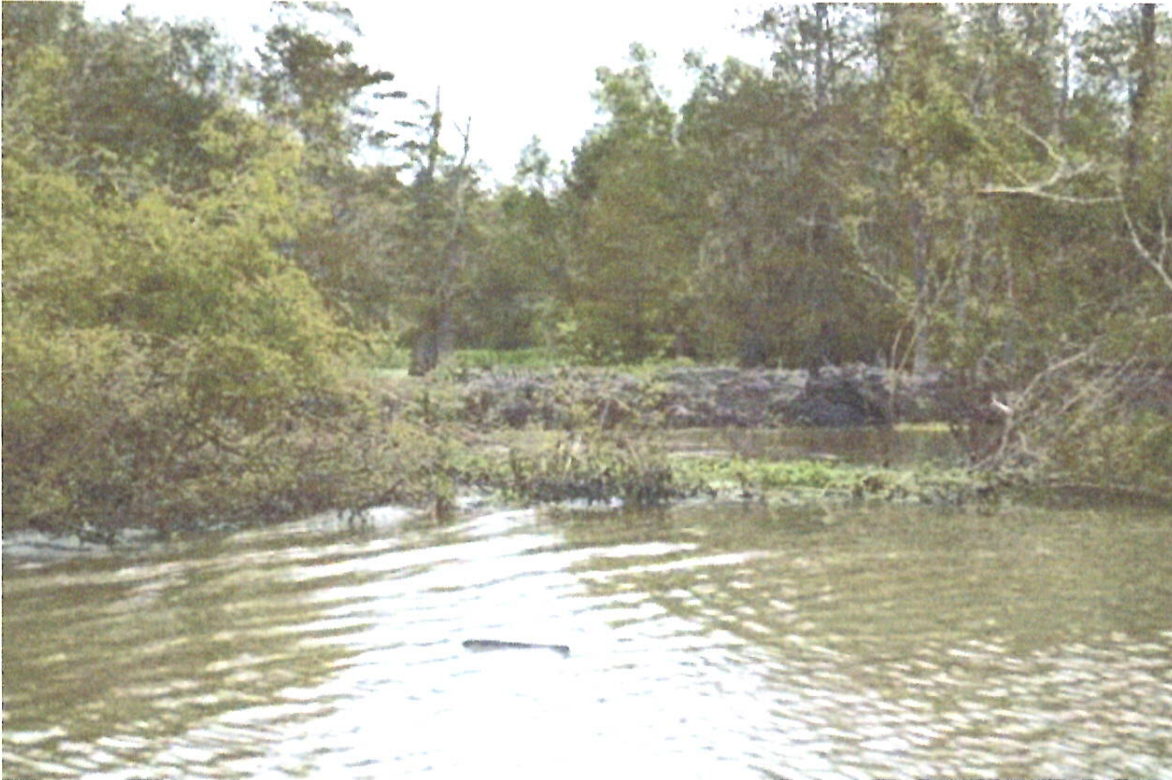
Another waterway dammed

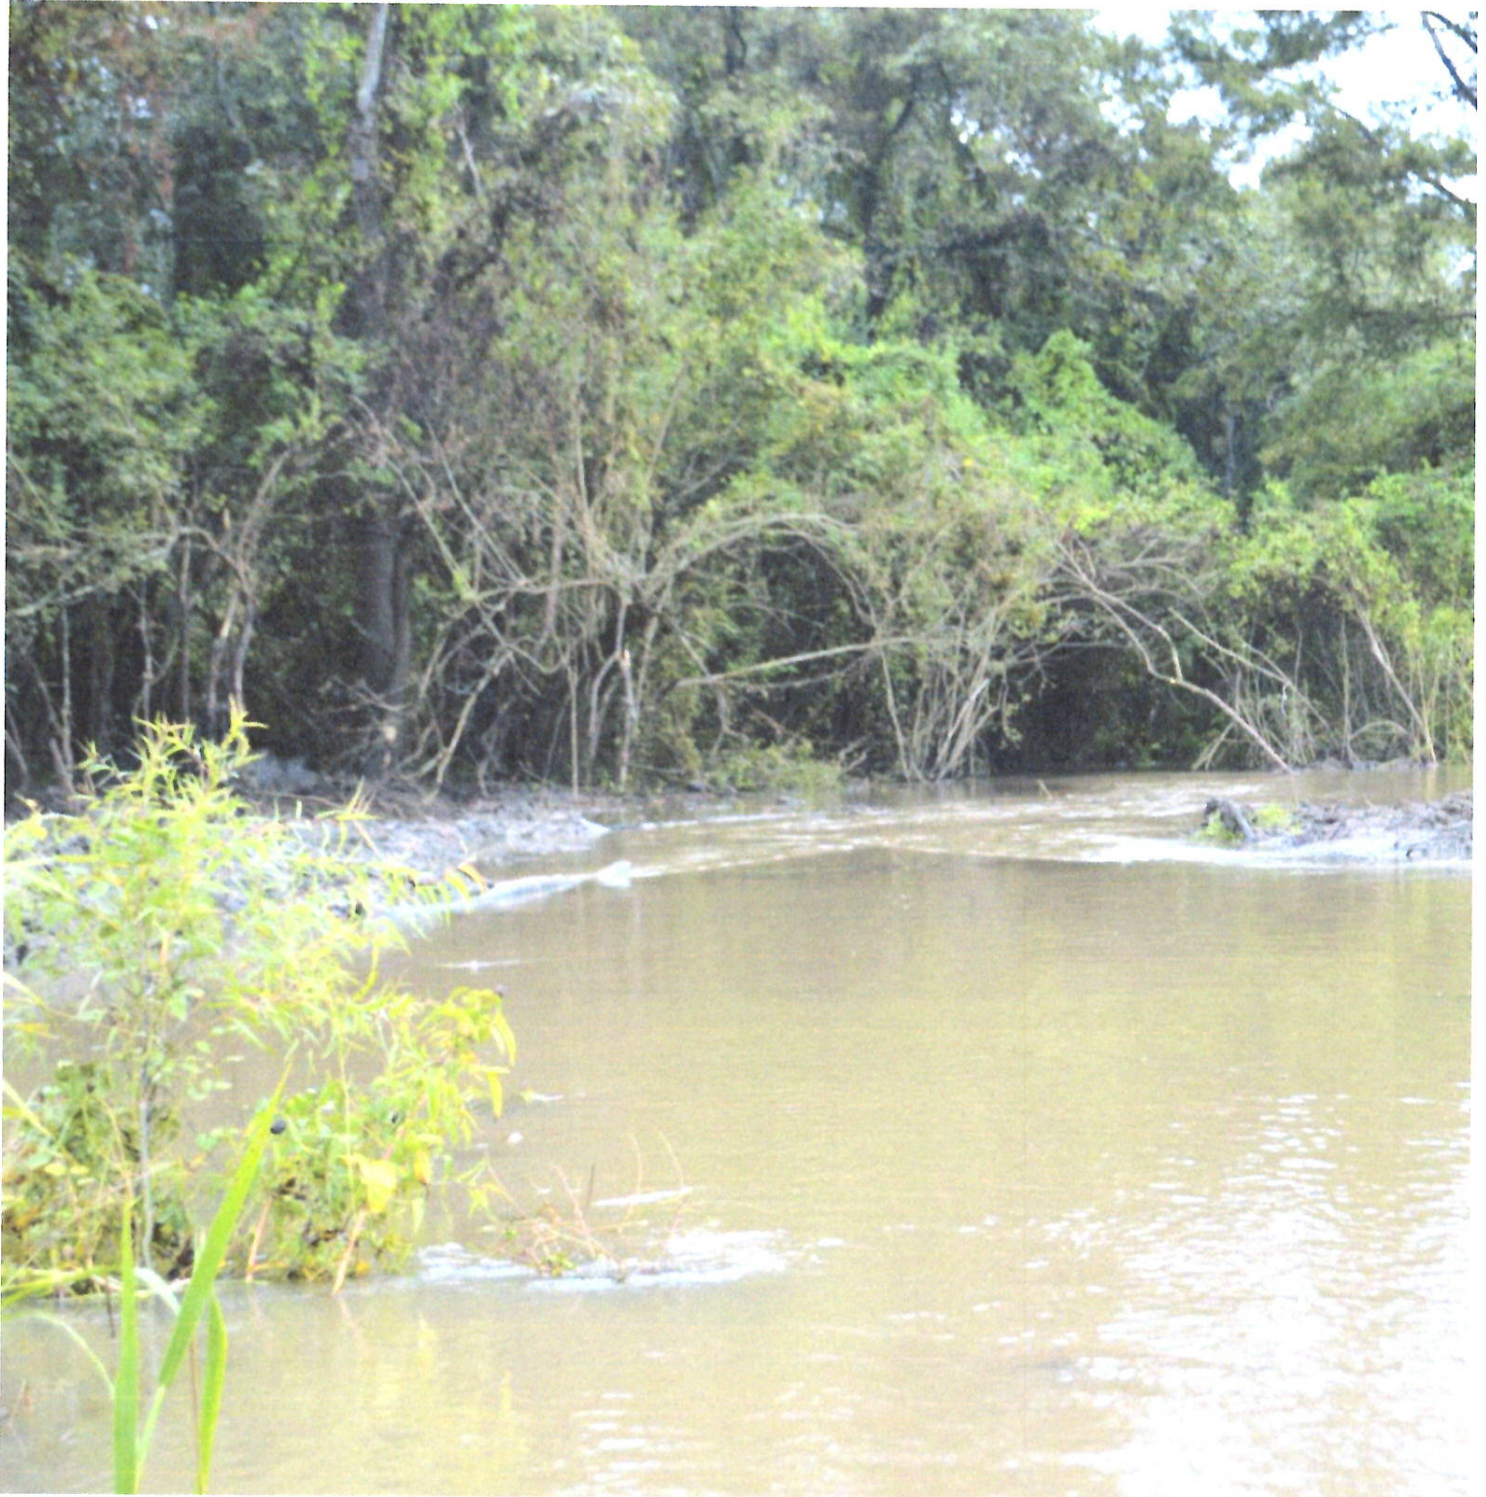
The Bayou Set dam was partially removed but is still impassible. At this water stage Bayou Set was about 3' deep at that location. Some spoil was left, the bayou is not as wide as it should be and le is the case I want to thank you. Commercial fishermen and one swamp tour company need access to the bayou.
