Post-Construction Notice of Violations (MVN 2015-02295-WII, WQC 160921-03) Atchafalaya Basinkeeper, Gulf Restoration Network and Louisiana Crawfish Producers Association-West

Re: Post-Construction Notice of Violations – Bayou Bridge Pipeline, LLC (MVN 2015-02295-WII; WQC 160921-03)

Monitoring Report:

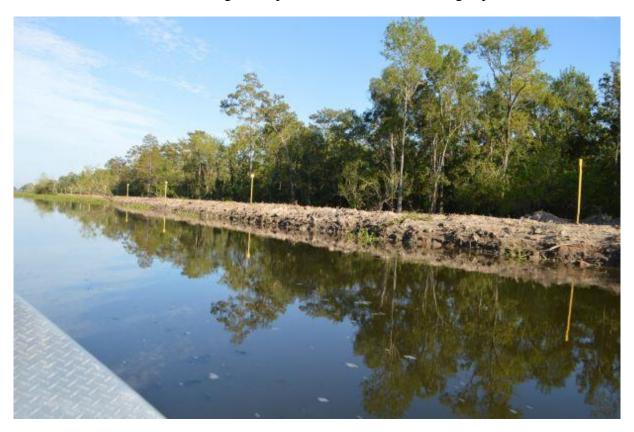
Fig. 1-W. September 11, 2019. This photo depicts Bayou Bridge pipeline markers in the spoil bank, and an absence of gaps in the spoil bank. Dean took this photo facing northeast, traveling northwest in the canal adjoining the right-of-way between the dike northwest of Bayou Chene

and Beau Bayou, between the following approximate coordinates: 30° 07'20.8" N, 91° 33'49.4" W to 30° 08'09.66" N, 91° 35'46.74" W.

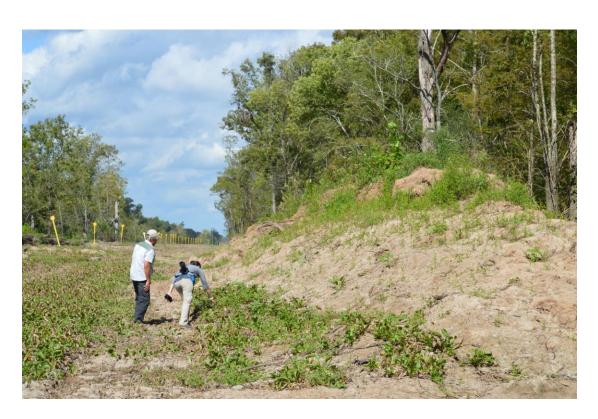
Fig. 2-W. September 27, 2019. This photo depicts illegal fill/Clean Water Act violation along the pipeline right-of-way. The pipeline is on the lower part of the picture without markings. The picture was taken facing northeast, approximate coordinates: 30° 07'38.37" N, 91° 34'27.79" W.

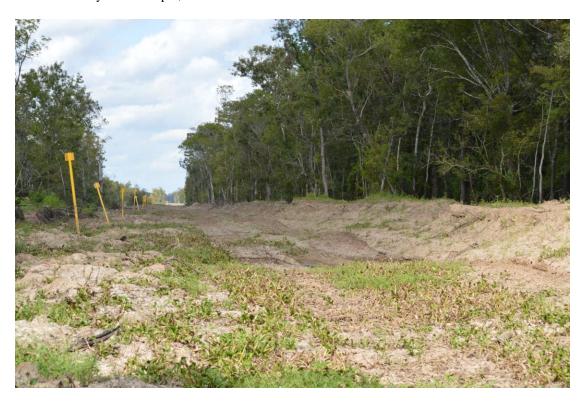
Fig, 3-W. September 27, 2019. This photo depicts the extent of the illegal fill/Clean Water Act violation along the pipeline right-of-way. The pipeline is on the lower part of the picture without markings. The picture was taken facing northeast, approximate coordinates: 30° 07'38.37" N, 91° 34'27.79" W.

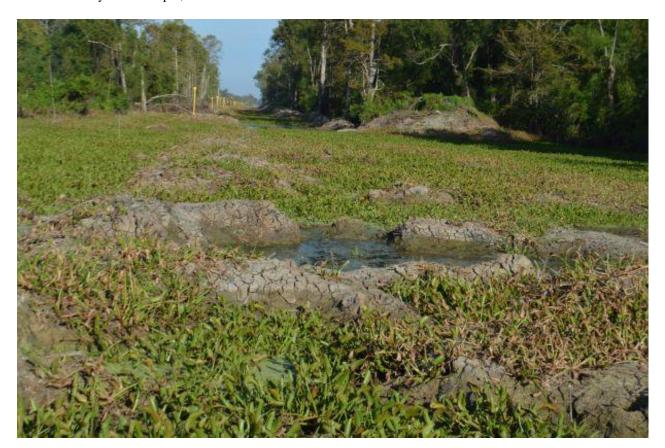
Fig. 4-W. September 11, 2019. This photo depicts piles of dredged material/dirt/spoil, including a large hill of dredged material to the right of the pipeline markers and channel, and large holes at the forefront remaining after pipeline construction, in violation of the permit. To the left of the photo, before the pipeline markers placed in elevated spoil, the pipeline trench is full of water and covered with water hyacinth, indicating that the pipeline appears to be uncovered or insufficiently covered at this location. This photo was taken from the west bank of Beau Bayou facing northwest, at the following approximate coordinates: 30°08'10.99" N, 91°35'48'68" W.

Fishermen crossing Beau Bayou, in the area near where this photo was taken, have reported hitting "something hard" with their propellers just in the time since the pipeline was laid in this area, in late summer 2018. If the pipeline is not appropriately covered, it could be hitting the fishermen's propellers as they navigate.

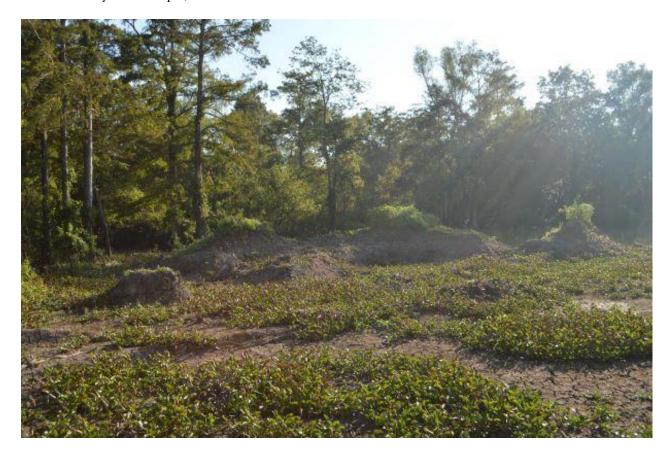
Fig. 5-W. September 11, 2019. This photo depicts more dredged material/dirt/spoil left along the pipeline right-of-way, in violation of the permit, with the pipeline located near the bottom of the photo without pipeline markers. Dean took this photo facing northeast between Beau Bayou and Bayou Chene, between the following approximate coordinates: 30° 08'09.66" N, 91° 35'46.74" W and 30° 07'20.8" N, 91° 33'49.4" W.

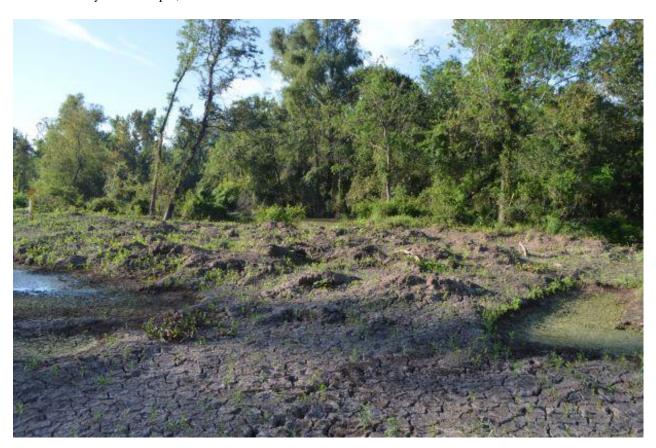
Fig. 6-W. September 11, 2019. This photo depicts yet more piles of dredged material/dirt/spoil and holes along the pipeline right-of-way, in violation of the permit. The pipeline trench is located in the lower portion of the photo, with water in the trench and what appears to be uncovered pipeline to the left side. Dean took this photo facing northwest between Beau Bayou and Bayou Chene, between the following approximate coordinates: 30° 08'09.66" N, 91° 35'46.74" W and 30° 07'20.8" N, 91° 33'49.4" W.

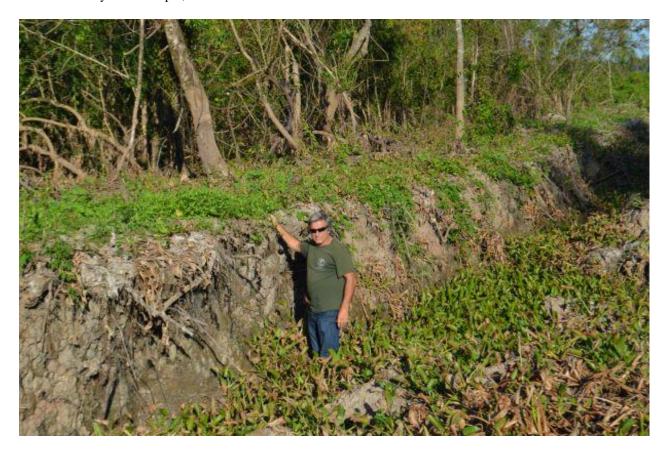
Fig. 7-W. This photo was taken by Shane Doucet during the September 11 monitoring trip. This photo depicts a large rut approximately 6' deep in the pipeline right-of-way, remaining after construction of the Bayou Bridge pipeline. Shane took this photo facing southwest very close to the dike that separates the canal to Bayou Chene, at the following approximate coordinates: 30° 07'20.8" N, 91° 33'49.4" W.

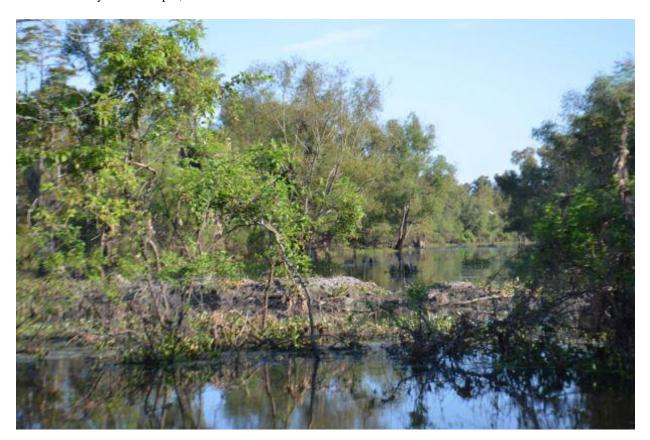
Fig. 8-W. September 11. 2019. This photo depicts one of the many damned waterways, between the following approximate coordinates: 30° 08'09.66" N, 91° 35'46.74" W and 30° 07'20.8" N, 91° 33'49.4" W. This waterway is located to the north of the pipeline. One of the many illegal fills/Clean Water Act violations by Bayou Bridge pipeline.

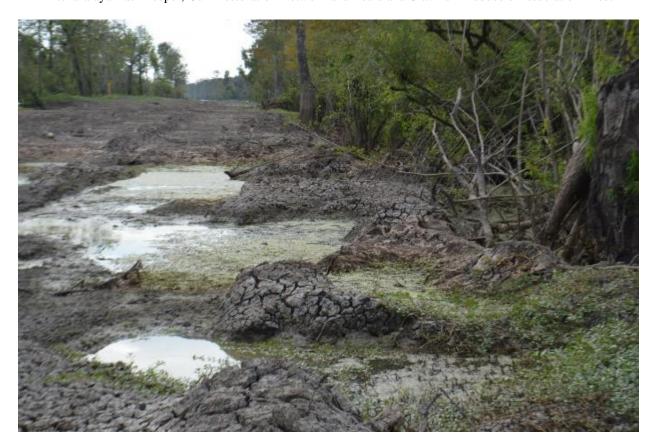
Fig. 1-E. This photo depicts piles of dredged material/dirt/spoil and large holes remaining after pipeline construction, in violation of the permit. Dean took this photo facing west from the banks of Cross Bayou, at the following approximate coordinates: 30°05'12.84" N, 91°22'38.47" W.

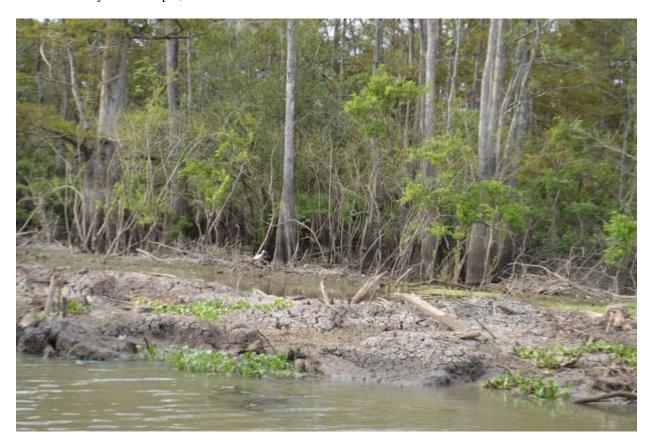
Fig. 2-E. This photo depicts illegal fill/Clean Water Act violations along the pipeline right-of-way after construction, and dirt in the adjoining forest likely as a result of digging during high water without using appropriate, required erosion controls. Dean took this photo facing north, with the pipeline trench in the bottom portion of the photo, between the following approximate coordinates: 30° 05'24.32" N, 91° 21'10.19" W to 30° 05'10.71" N, 91° 23'5129" W.

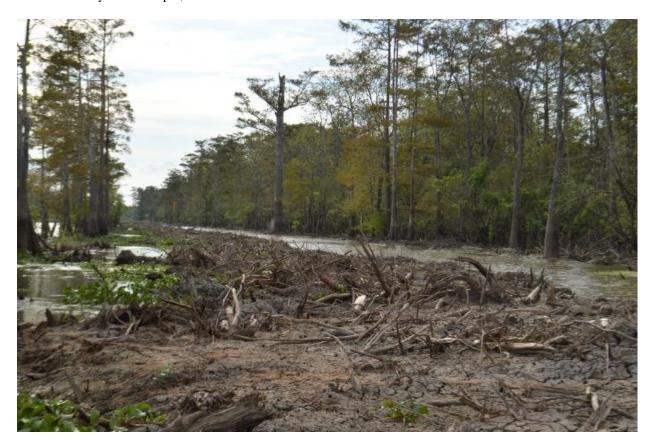
Fig. 3-E. This photo depicts illegal fill/Clean Water Act violations created by dredged material/dirt/spoil and debris remaining along the pipeline right-of-way after construction and pipeline markers placed inside new spoil created by BBP. Dirt seen in the adjoining the forest to the right side of the photo may likely have been the result digging/dredging during high water without any erosion control. Dean took this photo facing west/northwest at a location west of Cross Bayou, between the following approximate coordinates: 30°05'12.84" N, 91°22'38.47" W and 30° 05'10.71" N, 91° 23'51.29" W.

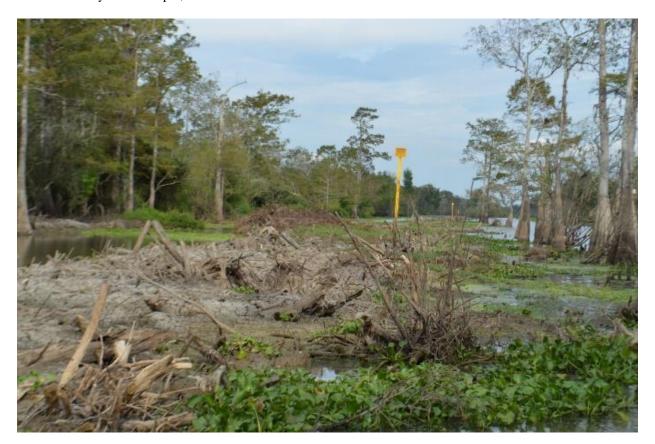
Fig. 4-E. This photo depicts illegal fill/Clean Water Act violations, dredged material/dirt/spoil and debris remaining along the pipeline right-of-way after construction and pipeline markers placed inside new spoil created by BBP. Dirt seen in the adjoining the forest to the left side of the photo may likely have been the result digging/dredging during high water without using appropriate, required erosion controls. Dean took this photo facing east, at a location east of Cross Bayou between the following approximate coordinates: 30° 05'12.84" N, 91°22'38.47" W and 30° 05'10.71" N, 91° 23'51.29" W.

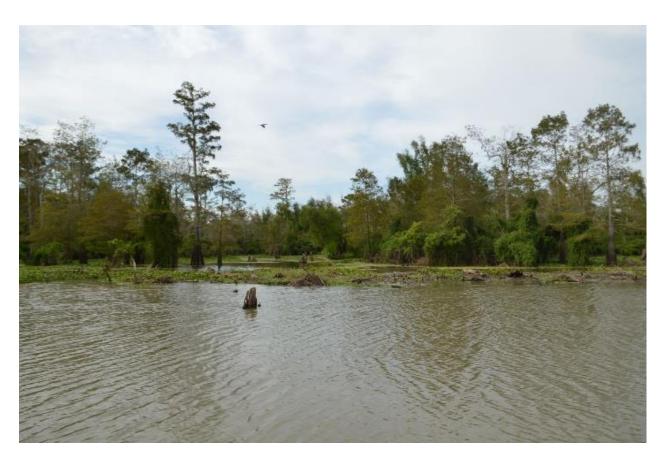
Fig. 5-E. This photo depicts a pre-existing, unnamed slough along the right-of-way that is dammed/blocked by construction-related debris, in violation of the permit. Dean took this facing north, at a location west of Cross Bayou between the following approximate coordinates: 30° 05'12.84" N, 91° 22'38.47" W and 30° 05'10.71" N, 91° 23'51.29" W.

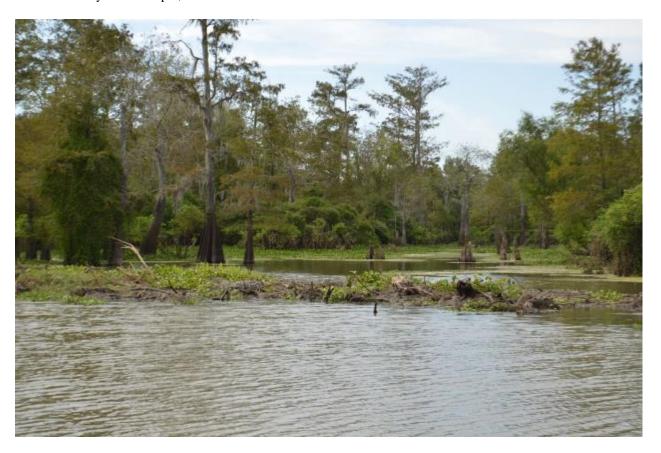
Fig. 6-E. This photo depicts another pre-existing, unnamed slough that is dammed/blocked by debris, an illegal fill/Clean Water Act violation. This slough was previously accessible by boat but now it is not. Dean took this facing north, at a location west of Cross Bayou between the following approximate coordinates: 30° 05'12.84" N, 91° 22'38.47" W and 30° 05'10.71" N, 91° 23'51.29" W.

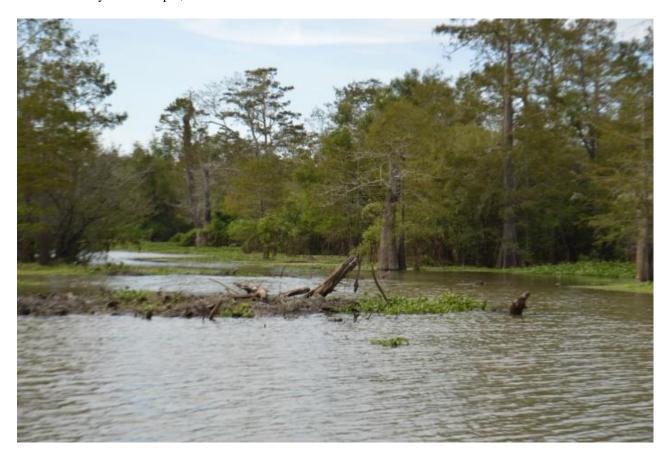
Fig. 7-E. This photo depicts another preexisting, unnamed slough, that is dammed by debris, another illegal fill/Clean Water Act violation. Dean took this facing north, at a location west of Cross Bayou between the following approximate coordinates: 30° 05'12.84" N, 91° 22'38.47" W and 30° 05'10.71" N, 91° 23'51.29" W.

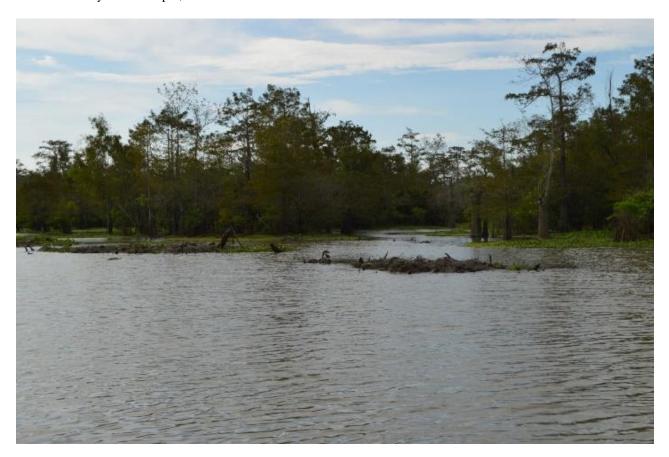
Fig. 8-E. This photo depicts another pre-existing, unnamed slough, that is dammed by debris, another illegal fill/Clean Water Act violation. Dean took this facing north, at a location west of Cross bayou between the following approximate coordinates: 30° 05'12.84" N, 91° 22'38.47" W and 30° 05'10.71" N, 91° 23'51.29" W.

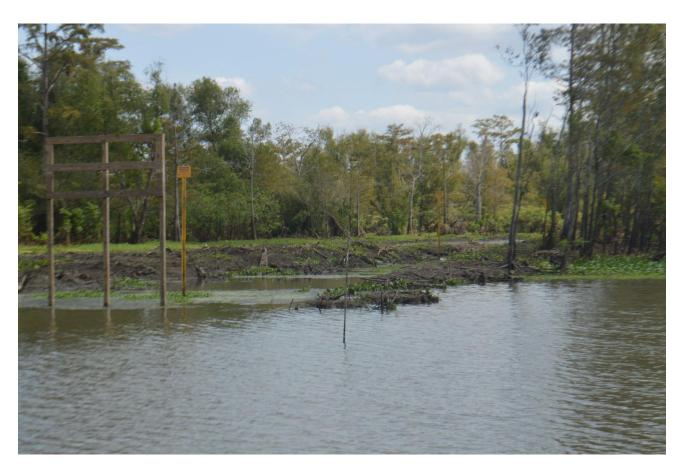
Fig. 9-E. This photo depicts markers in a the flooded pipeline trench, suggesting that in portions where the pipeline trench remains inundated with water at such a low water stage that the pipeline in these areas is uncovered or insufficiently covered per the terms of the permit (minimum of 4' cover). Dean took this photo facing northeast, at the following approximate coordinates: 30°05'16'61" N, 91°22'18.23" W.

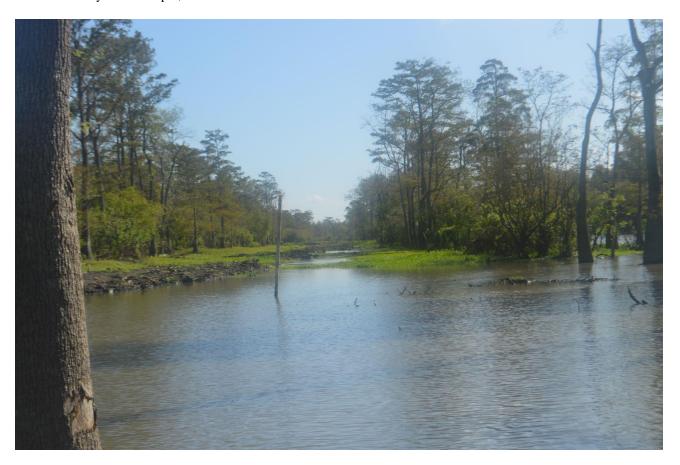
Fig. 10-E. As in fig. 9-E above, this photo depicts an inundated trench and pipeline markers in the flooded trench, again indicating that the pipeline is uncovered or insufficiently covered. Dean took this photo facing east, at the following approximate coordinates: 30°05'12.91" N, 91°22'27.85" W.
