Expert Report

Evaluation of US EPA Site Characterization and Remedial Assessment Data

Residents of Gordon Plaza, Inc. v. City of New Orleans
United States District Court for the Eastern District of Louisiana

EnviroForensics, LLC has developed a Site Characterization Work Plan that in my opinion will adequately characterize the environmental conditions at the site. The work scope is attached as Appendix C and is summarized to include:

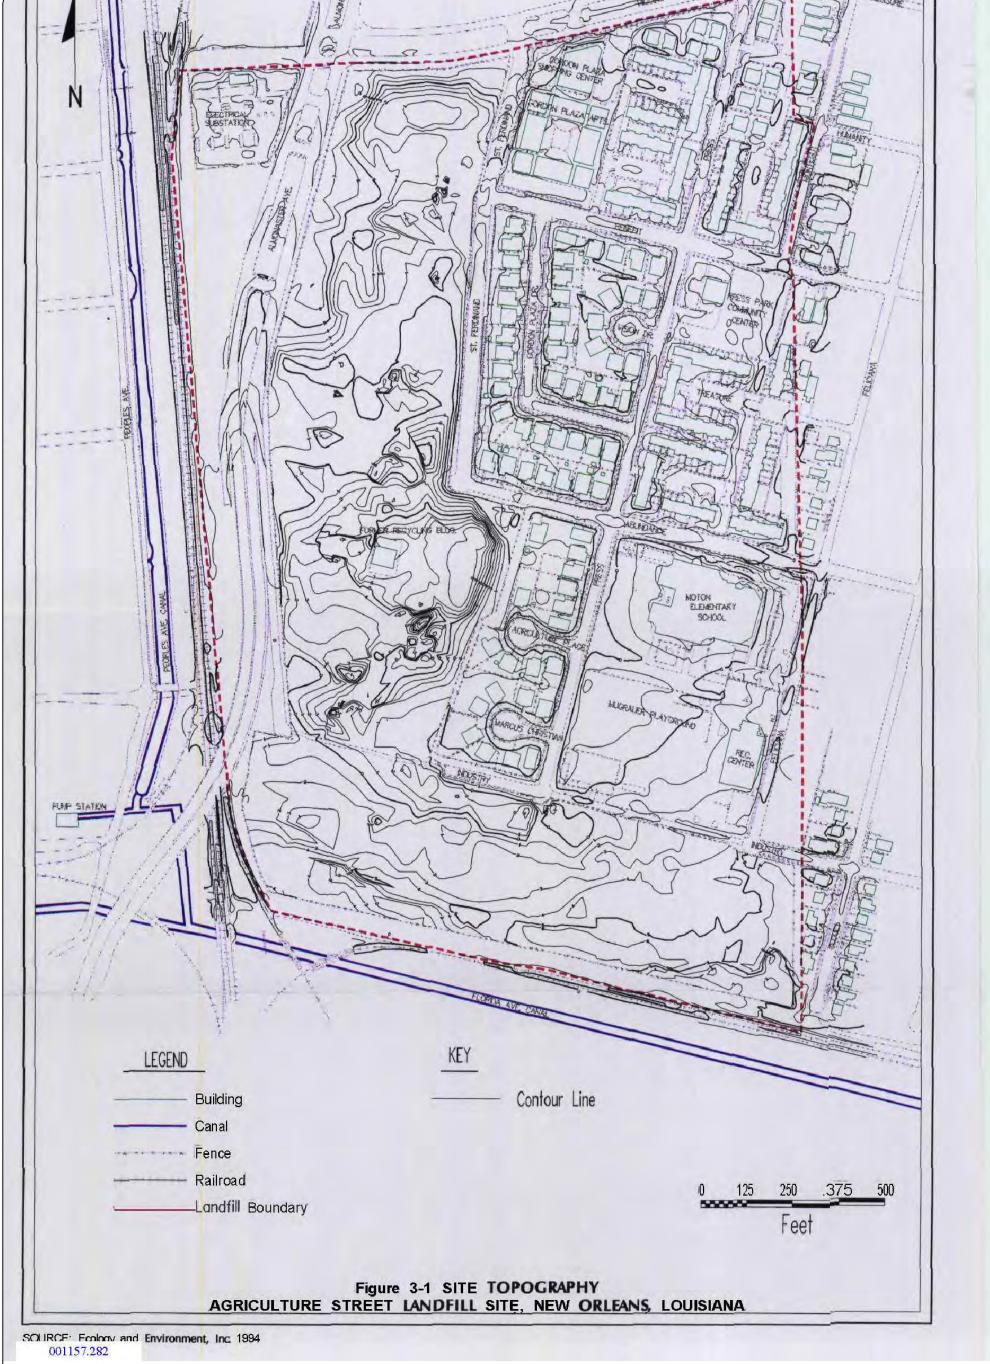
SITE TOPOGRAPHY 6/13/19 Date Revision Approved Date: Figure Designed: EB 4 Drawn: EB Agriculture Street Landfill Project BK Checked: 825 North Capitol Avenue • Indianapolis, IN 46204 300002 DWG file: 300002-0139 EnviroForensics.com

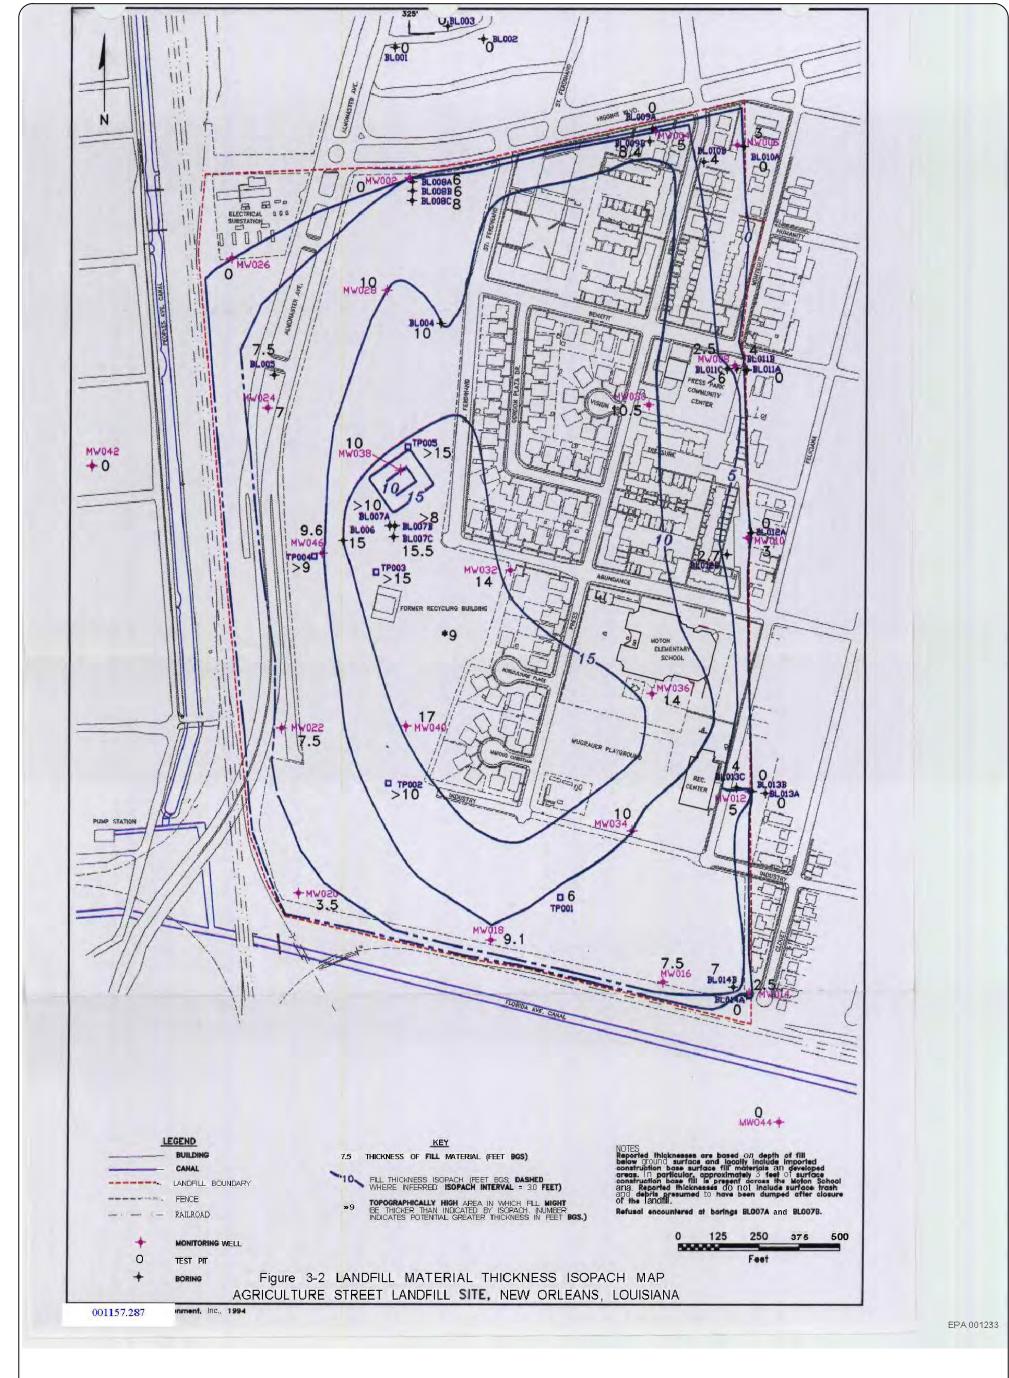
No.	Date	Revision	Approved		Date:	6/13/19	LANDFILL MATERIAL THICKNESS ISOPACH MAP	Figure
				ENVIRO Herensics	Designed:	EB	Agriculture Street Landfill	5
					Drawn:	EB		
				COS North Control Avenue & Judice and Jan 19004	Checked:	BK		Project
				825 North Capitol Avenue ● Indianapolis, IN 46204 EnviroForensics.com	DWG file: 300	002-0139		300002

- 26. In April 1976, the Gillen Engineering Company submitted a report stating that fill material ranging from 2.5 to 33 feet below ground surface was observed in the area of the Gordon Plaza Housing Development Project. Because of the amount of and variation in depth of the fill, the report indicated that a large amount of subsidence could occur (RRII, 1-29). The report stated, "most of the fill material, if not all, should be removed" (Gillen 1976 (White 1985 (RRII, 1-29)). An April 1980 report from J.J. Krebs and Sons, Inc. emphasized that the building foundations would have to be designed properly and special construction features for driveways and sidewalks should be employed (RRII, 1-29). Recommendations were offered for construction of residential foundations, driveways, sidewalks and walkways, installation of gas venting systems for addressing potential methane gas migration and for the suspension of utilities below building slabs. (Hansel 1980 (White 1985 (RRII, 1-29))). A January 1984 subsoil investigation by Gore Engineering noted that flammable gas was encountered during its soil investigation on the Moton School property and recommended a gas collection or treatment system (RRII, 1-30). In May 1984, J.J. Krebs and Sons, Inc. made several recommendations regarding ventilation at the Moton School to address gases below buildings (Hansel 1980 (White 1985 (RRII, 1-29))).

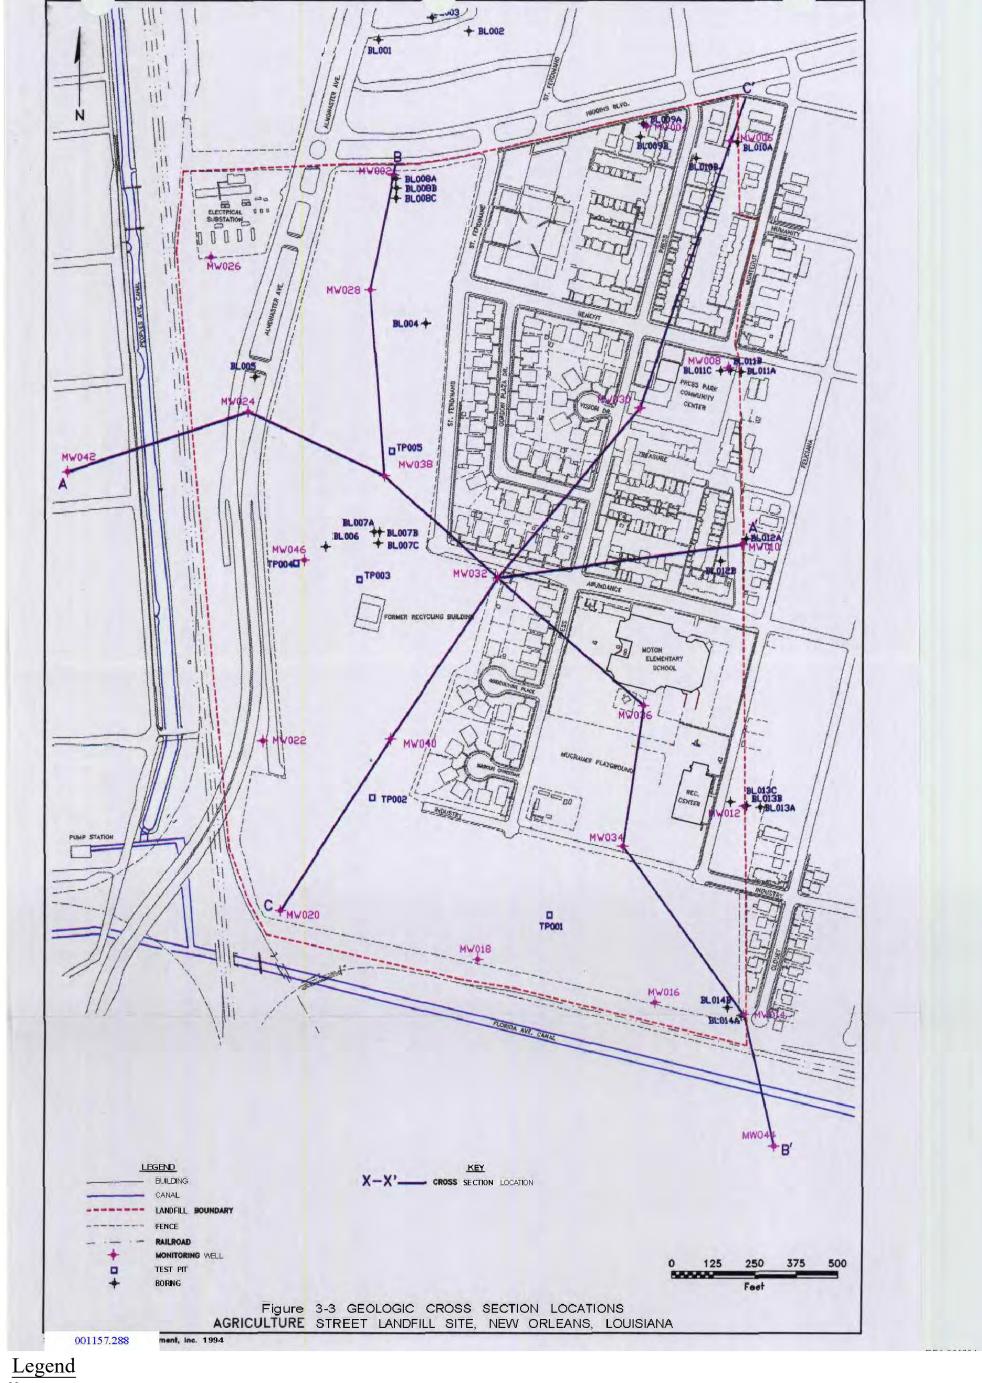
No.	Date	Revision	Approved		Date:	6/13/19	GEOLOGIC CROSS-SECTION LOCATIONS	Figure
				ENVIRO forensics	Designed:	EB	Agriculture Street Landfill	6
					Drawn:	EB		
				005 N # 0 * 1 A * 1 B * 1 B * 40004	Checked:	BK		Project
				825 North Capitol Avenue ● Indianapolis, IN 46204 EnviroForensics.com	DWG file: 30	00002-0139		300002

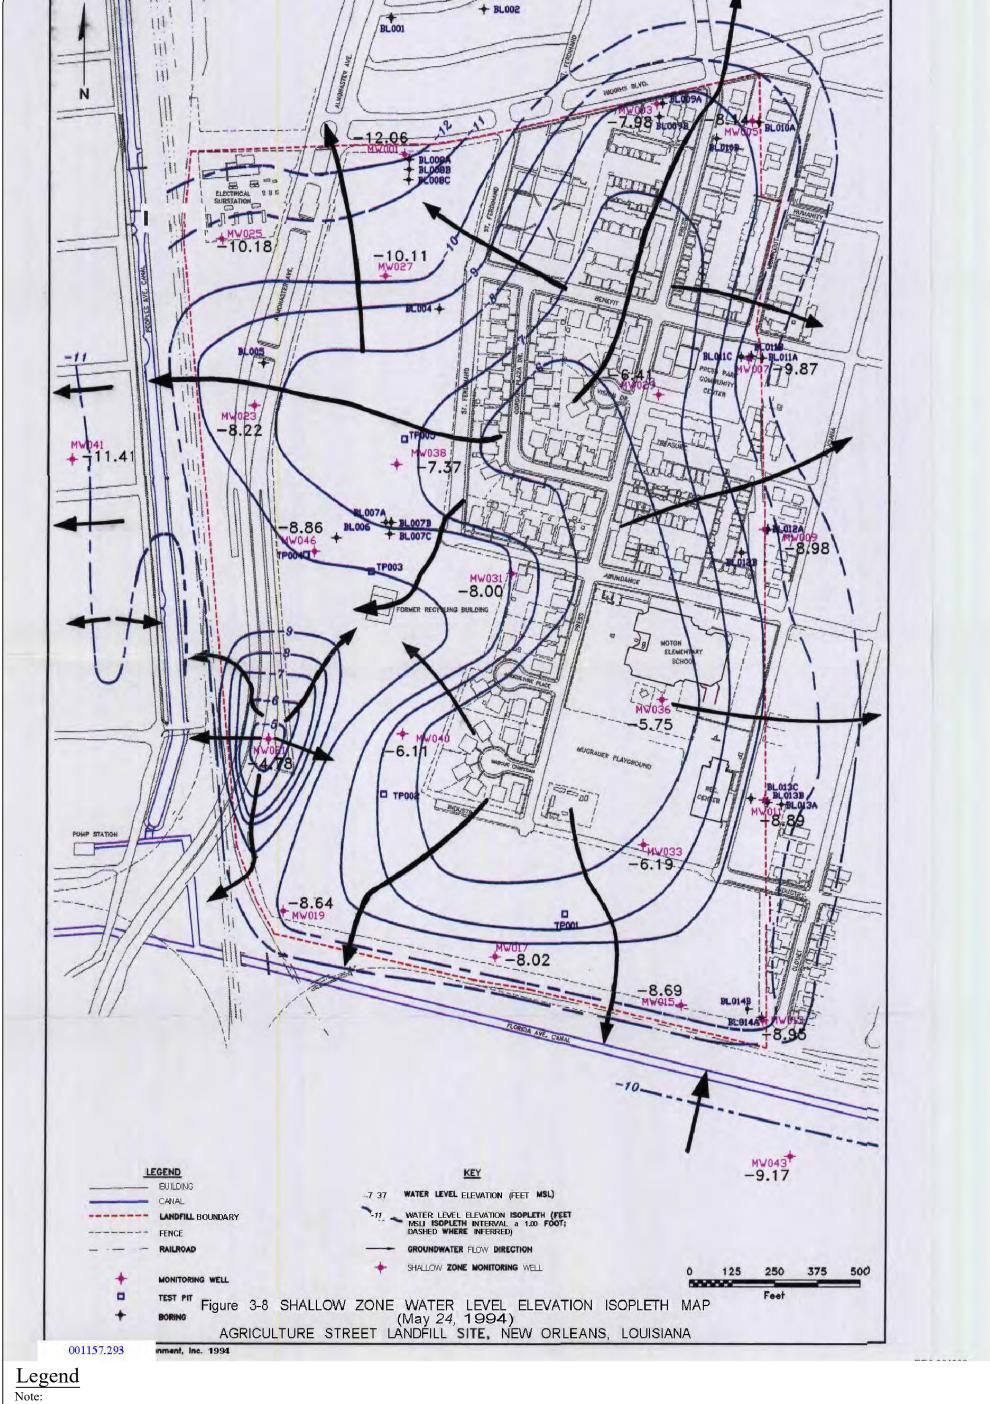
No.	Date	Revision	Approved		Date:	6/13/19	SHALLOW ZONE WATER LEVEL ELEVATION	Figure
				ENVIRO Perensics	Designed:	EB	ISOPLETH (MAY 24, 1994)	11
					Drawn:	EB	Agriculture Street Landfill	
				005 N # 0 * 1 A	Checked:	BK	8	Project
				825 North Capitol Avenue ● Indianapolis, IN 46204 EnviroForensics.com	DWG file: 30	0002-0139		300002

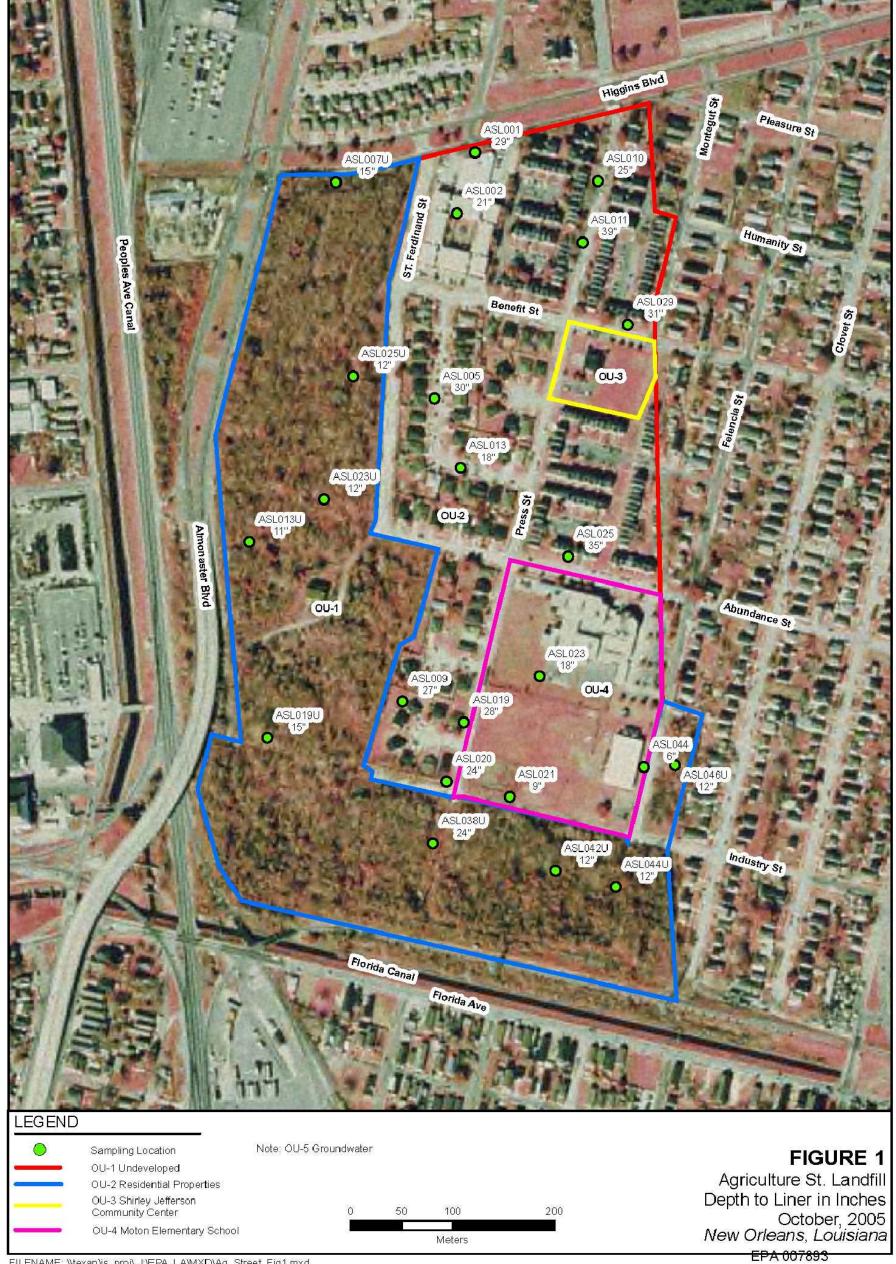
N	. Dat	e Revision	Approved		Date:	6/13/19	DEPTH TO LINER IN INCHES (2006)	Figure
					Designed:	EB		12
					Drawn:	EB	Agriculture Street Landfill	
					Checked:	BK	8	Project
C				825 North Capitol Avenue ● Indianapolis, IN 46204 EnviroForensics.com	DWG file: 300	0002-0139		300002

3.2 Soil Cover Condition

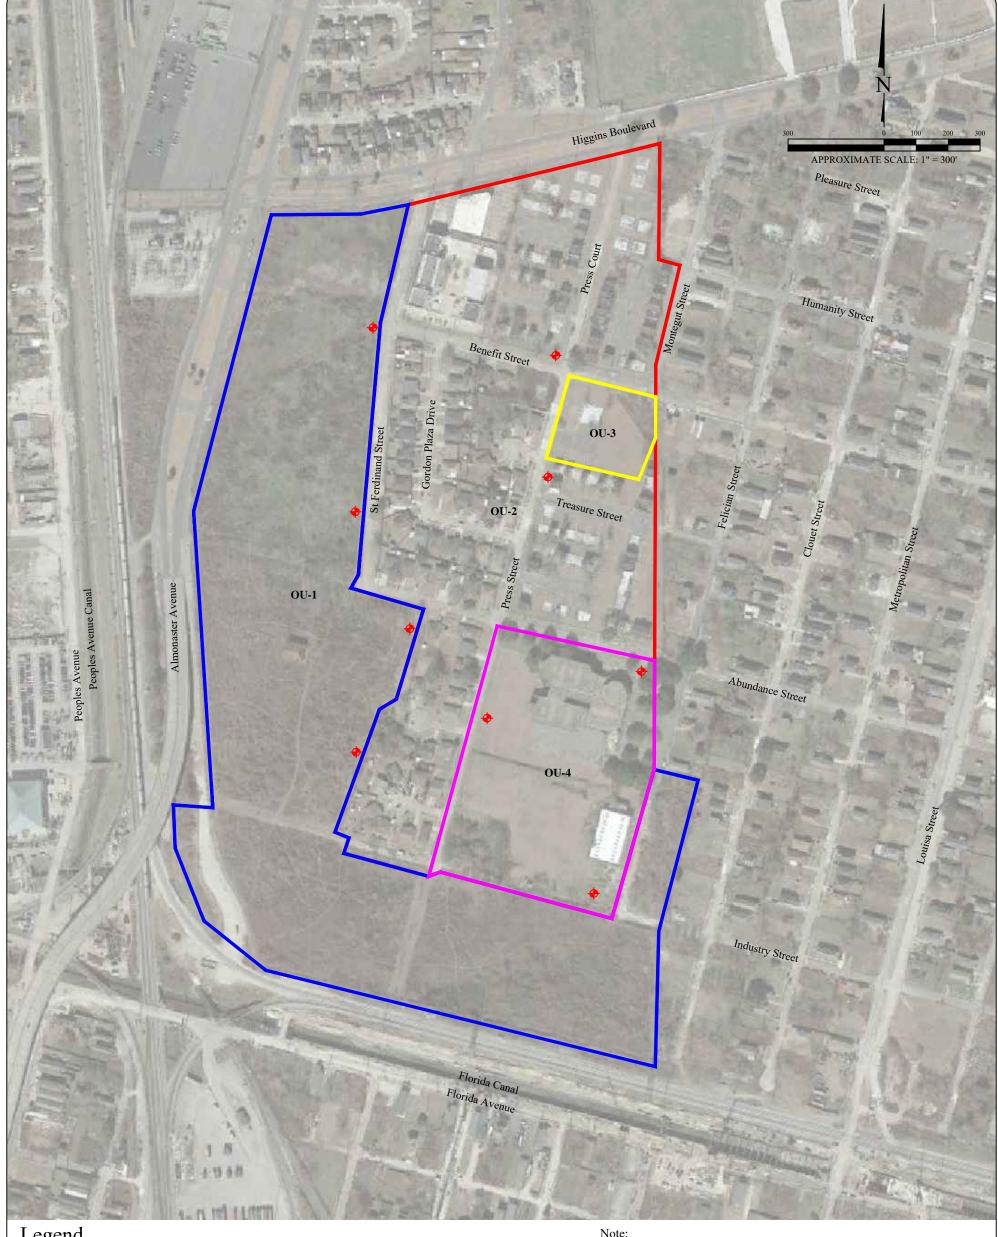
Figure 13 Project 300002

Agriculture Street Landfill

OA-1 = Undeveloped Land OA-2 = Residential Properties

OA-3 = Community Center

The soil boring plan is illustrated and summarized on **Figure 13**. Within the randomly assigned grid area, borings will be advanced near every grid node or as described above. Minor adjustments to boring locations may be necessary in the field to avoid subsurface obstructions. Additionally, samples will not be collected within the footprint of the Moton Elementary School building. Soil boring locations will be recorded in the field with a Global Positioning System (GPS) unit with an accuracy of 10 feet. This will provide a field reference for later, more accurate surveying.

Soil samples will be collected from the undeveloped portion of the landfill on a randomly assigned 100-foot grid as shown on **Figure 13**.

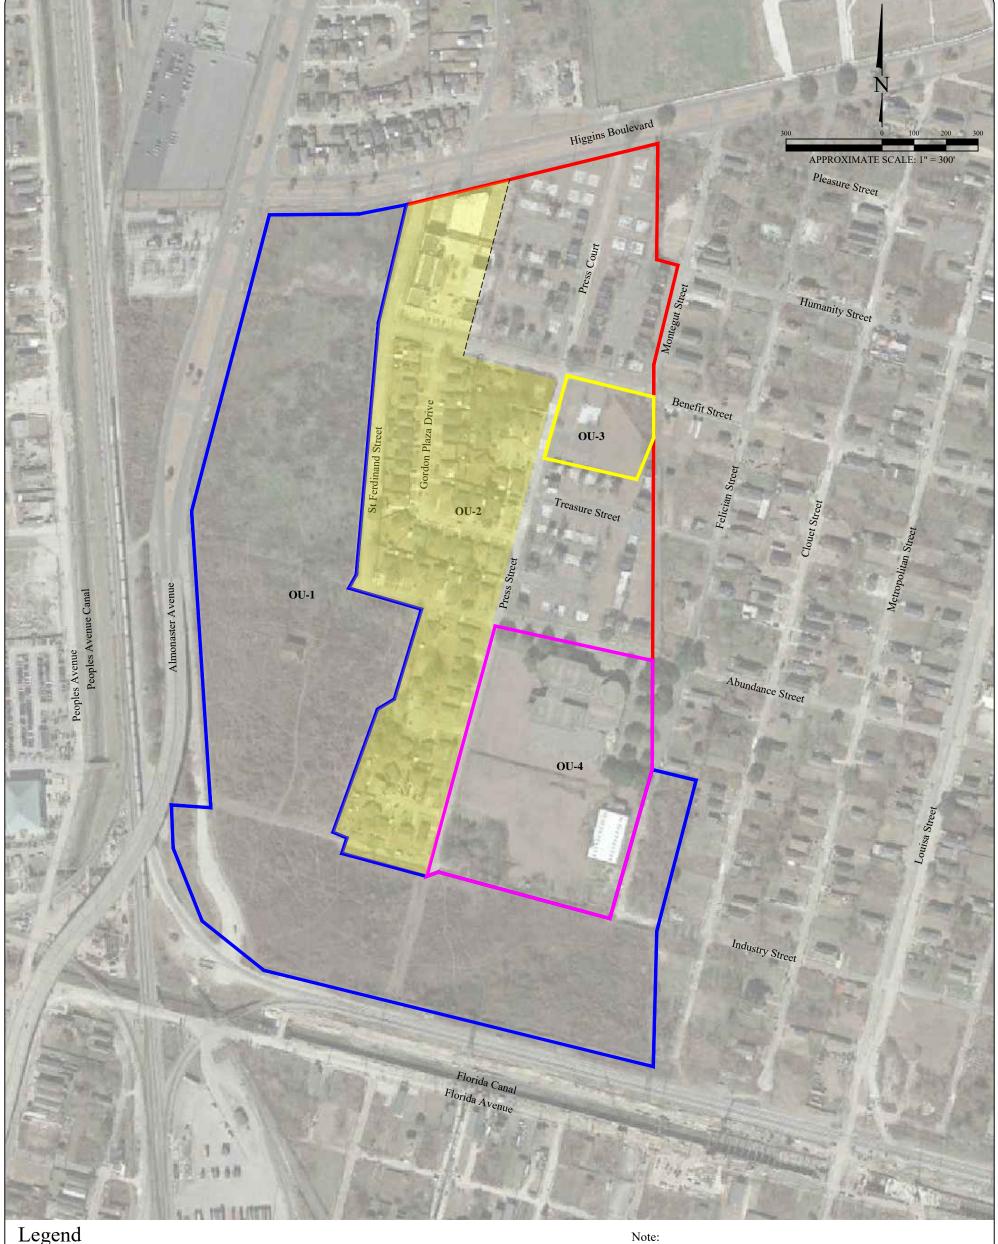
OA-3 = Community Center
OA-4 = Former Moton Elementary School
Sample Grid 100' by 100'

- 50. Collecting soil samples from 237 soil borings established on a 100-foot grid across the residential properties (not in the roadways or beneath building foundations), plus two additional samples to be collected on each residential property;
