COON TRAP CATASTROPHIC BANK FAILURE IMMINENT

EMERGENCY ACTION REQUESTED

January 26, 2021

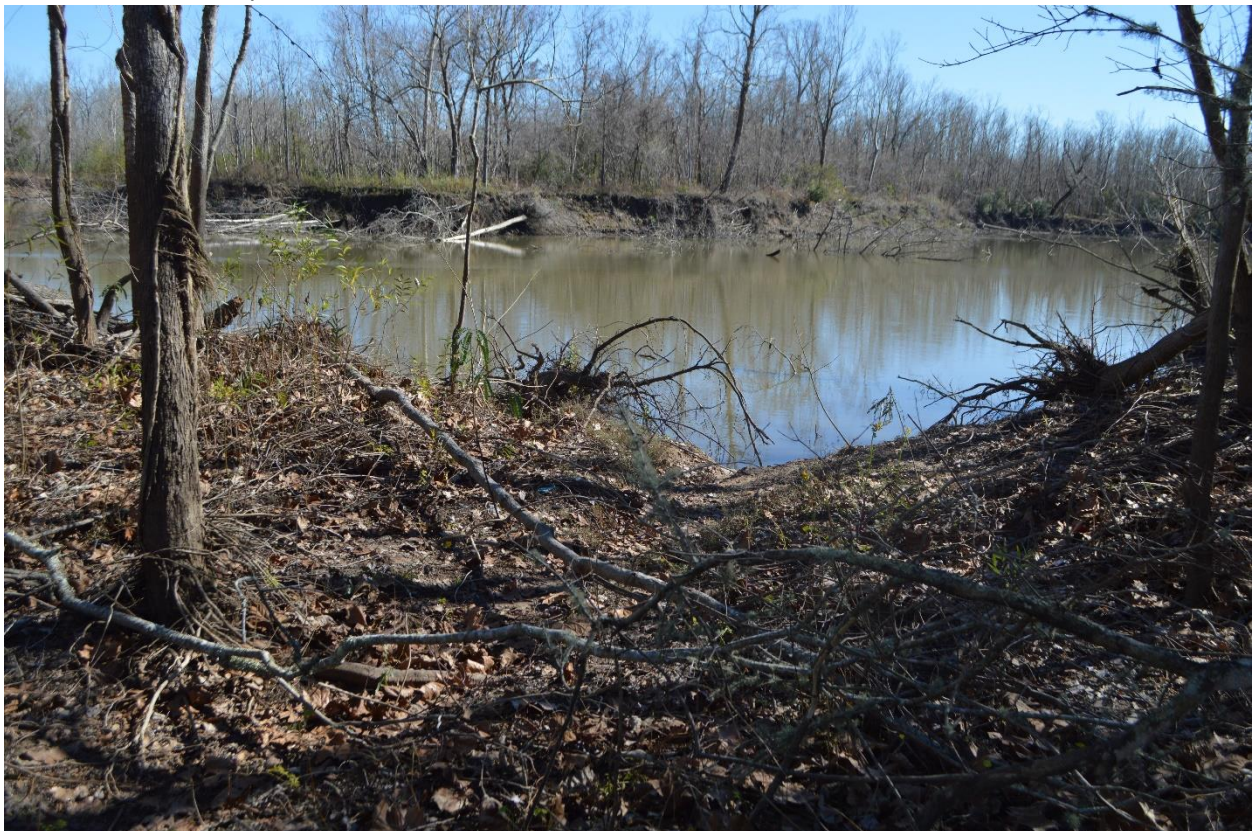
Picture taken January 5, 2021:

Massive erosion already took place about 2 weeks ago from barge waves going over the bank.

We are requesting that the Corps take immediate action, like arming with rocks the strip of land that is about collapse or other best possible means to avoid the Atchafalaya River diversion to the area. Failure to take immediate action will cost hundreds of millions of dollars in environmental damage and the permanent loss of Basin flood capacity.

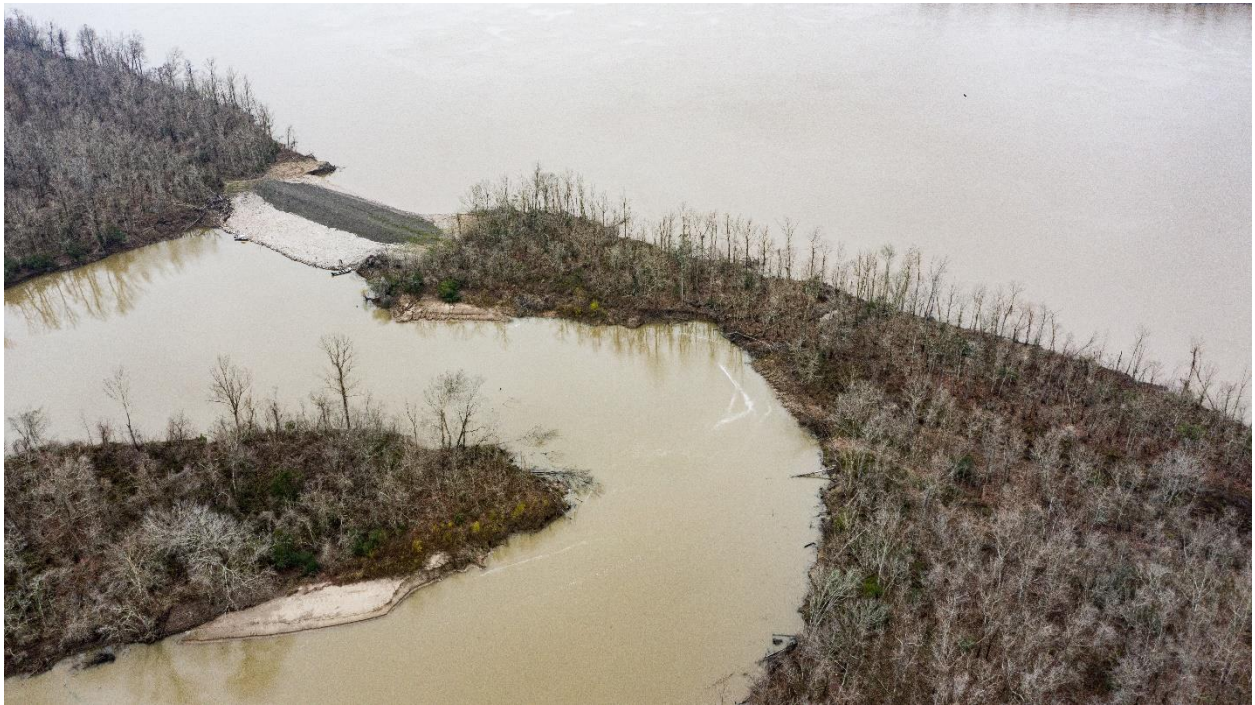
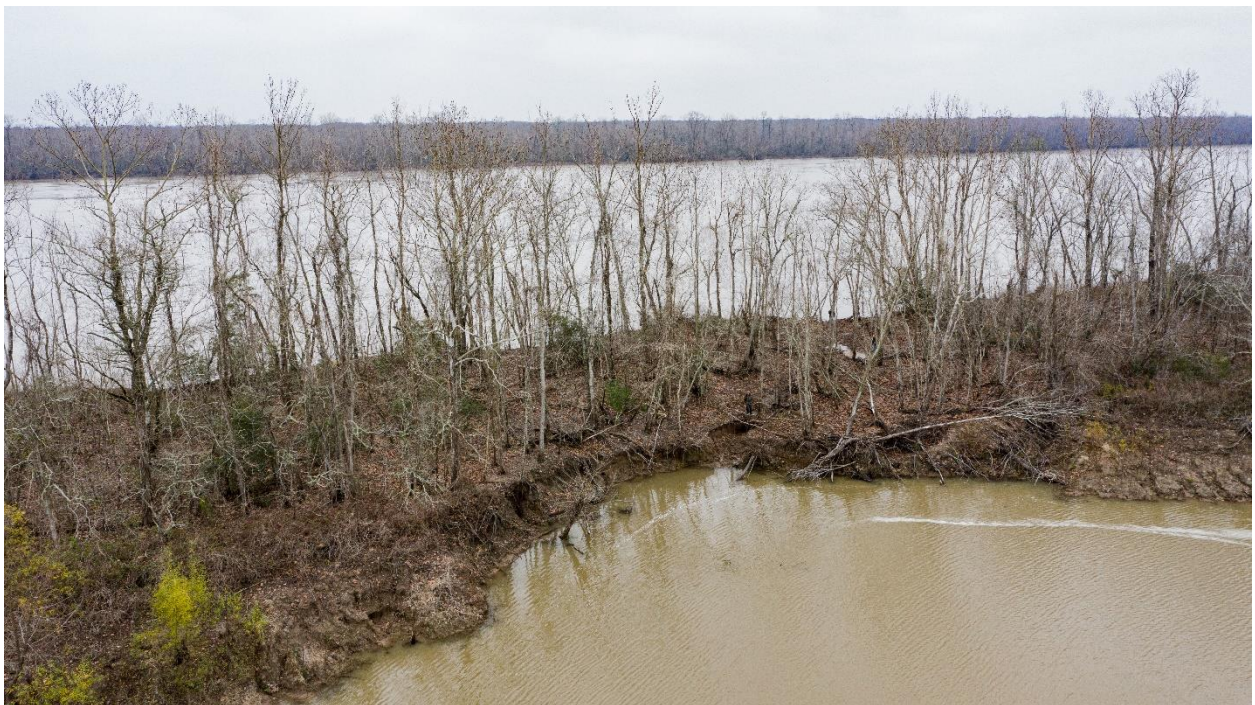
Coon Trap aerals:

Coon Trap is the name of an Atchafalaya River diversion into the East Grand Lake Unit that was closed in 2020. The bank of the Atchafalaya River is about to be breached and a new channel will form creating a new river diversion into the Coon Trap channel, way worse than the original Coon Trap that was dammed. The original Coon Trap opening had a rock bottom that prevented the opening from becoming deeper and more efficient, not such a thing for the new channel that is about to form as soon as the Atchafalaya River water raises about 2 feet. The fact that Coon Trap is closed means that the water levels in the Coon Trap Channel are much lower greatly increasing the force of the water into the channel. The failure will be imminent and catastrophic, greatly decreasing the Basin's flood capacity, the environmental damage irreparable.
